Access Compliance Report

Public Rights-of-Way

(Curb Ramps)

Intersection ID: 45174	Main Street: LINDEN_TREE_LN	Cross Street: SOCIETY_ST	Location: NE
ADA ID: 7466E4D1F116	Ramp Type: PerpDiag	Initial Pass/Fail: Fail	Overall Compliance: No
		Severity Score: 10

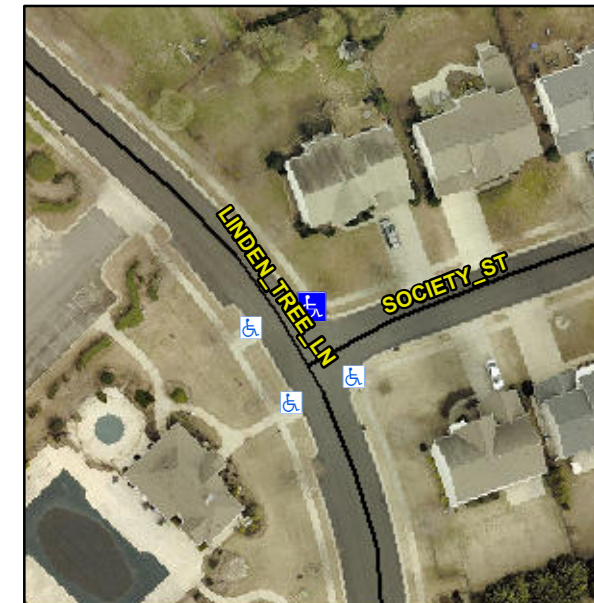
Not Found, R304.5.1, R304.5.3

Compliance	Description	Data	Compliance	Description	Data
N/A	Ramp Length (in)	47.5	Yes	Ramp Slope (%)	5.0
No	Ramp Width (in)	44.5	No	Ramp XSlope (%)	4.1
N/A	Flare Type LT	N/A	N/A	Flare Type RT	N/A
N/A	Flare Slope LT (%)	N/A	N/A	Flare Slope RT (%)	N/A
N/A	Flare Traversable LT?	N/A	N/A	Flare Traversable RT?	N/A
N/A	Landing Length (in)	N/A	N/A	DWS Provided?	N/A
N/A	Landing Width (in)	N/A	N/A	DWS Contrast?	N/A
N/A	Landing Slope (%)	N/A	N/A	DWS Length (in)	N/A
N/A	Landing X Slope (%)	N/A	N/A	DWS Full Width?	N/A
N/A	Landing Curb? (Y/N)	N/A	N/A	DWS Offset (in)	N/A
N/A	Shared Landing?	N/A			
N/A	Gutter Ponding?	N/A	N/A	Gutter Slope (%)	N/A
N/A	Gutter Lip Ht (in)	N/A	N/A	Gutter X Slope (%)	N/A
N/A	Painted X Walk1?	No	N/A	Painted X Walk2?	No
	X Walk 1 Direction	To SW		X Walk 2 Direction	To SE
N/A	X Walk 1 Width (in)	N/A	N/A	X Walk 2 Width (in)	N/A
	X Walk 1 Slope (%)	5.1		X Walk 2 Slope (%)	0.9
	X Walk 1 X Slope (%)	2.2		X Walk 2 X Slope (%)	0.5

N/A	Ramp inside XWalk1?	N/A	N/A	Ramp inside XWalk2?	N/A
	Road Slope (%)	1.3	N/A	Clear Space?	N/A
	Road X Slope (%)	2.4	N/A	Clear Space to XWalk (in)	N/A
N/A	Any Obstructions?	N/A	N/A	Storm Grate/Utility Hazard?	N/A
	Obstruction Type			Storm Grate/Utility Type	
		N/A			N/A
			Yes	Surface Condition? (G/P)	Good

Remove & Replace Curb Ramp With Two New Directional Ramps or Equivalent.
