Access Compliance Report

Public Rights-of-Way

(Curb Ramps)

Intersection ID: 53224	Main Street: URBAN_PL	Cross Street: GIVENS_WY	Location: NW
ADA ID: 7468FBF044BE	Ramp Type: Perp	Initial Pass/Fail: Fail	Overall Compliance: No
Severity Score: 8.75			
Codes/Mitigation Info/Possible Solution		Field Measurements/Component Compliance

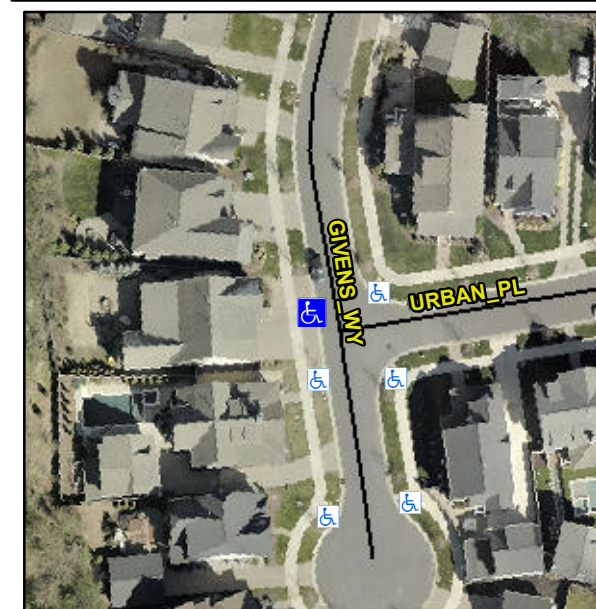
Not Found, R304.5.1

Compliance	Description	Data	Compliance	Description	Data
N/A	Ramp Length (in)	99.5	Yes	Ramp Slope (%)	5.4
No	Ramp Width (in)	39.0	Yes	Ramp XSlope (%)	0.2
N/A	Flare Type LT	N/A	N/A	Flare Type RT	N/A
N/A	Flare Slope LT (%)	N/A	N/A	Flare Slope RT (%)	N/A
N/A	Flare Traversable LT?	N/A	N/A	Flare Traversable RT?	N/A
N/A	Landing Length (in)	N/A	N/A	DWS Provided?	N/A
N/A	Landing Width (in)	N/A	N/A	DWS Contrast?	N/A
N/A	Landing Slope (%)	N/A	N/A	DWS Length (in)	N/A
N/A	Landing X Slope (%)	N/A	N/A	DWS Full Width?	N/A
N/A	Landing Curb? (Y/N)	N/A	N/A	DWS Offset (in)	N/A
N/A	Shared Landing?	N/A			
N/A	Gutter Ponding?	N/A	N/A	Gutter Slope (%)	N/A
N/A	Gutter Lip Ht (in)	N/A	N/A	Gutter X Slope (%)	N/A
N/A	Painted X Walk1?	No	N/A	Painted X Walk2?	N/A
	X Walk 1 Direction	To E		X Walk 2 Direction	N/A
N/A	X Walk 1 Width (in)	N/A	N/A	X Walk 2 Width (in)	N/A
	X Walk 1 Slope (%)	2.2		X Walk 2 Slope (%)	N/A
	X Walk 1 X Slope (%)	0.5		X Walk 2 X Slope (%)	N/A

N/A	Ramp inside XWalk1?	N/A	N/A	Ramp inside XWalk2?	N/A
	Road Slope (%)	N/A	N/A	Clear Space?	N/A
	Road X Slope (%)	N/A	N/A	Clear Space to XWalk (in)	N/A
N/A	Any Obstructions?	N/A	N/A	Storm Grate/Utility Hazard?	N/A
	Obstruction Type			Storm Grate/Utility Type	
		N/A			N/A
			Yes	Surface Condition? (G/P)	Good

Remove & Replace Entire Ramp.
