Access Compliance Report

Public Rights-of-Way

(Curb Ramps)

Intersection ID: 42683	Main Street: RUNNYMEDE_LN	Cross Street: SHARON_RD	Location: NW
ADA ID: 746FBA0DBE78	Ramp Type: Perp	Initial Pass/Fail: Fail	Overall Compliance: No
Codes/Mitigation Info/Possible Solution		Field Measurements/Component Compliance	
Severity Score: 33.75

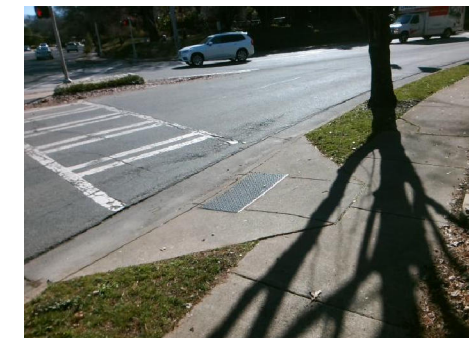
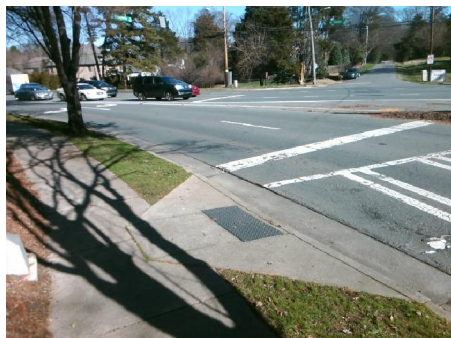
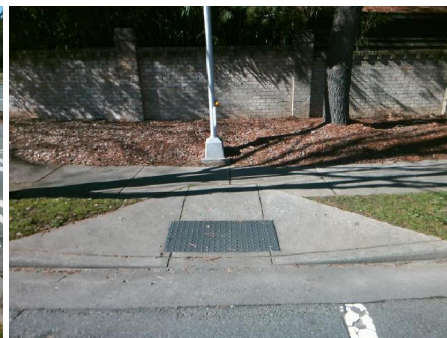
Not Found, R304.5.1, R304.2.2

Compliance	Description	Data	Compliance	Description	Data
N/A	Ramp Length (in)	70.0	No	Ramp Slope (%)	12.2
No	Ramp Width (in)	40.8	Yes	Ramp XSlope (%)	0.5
N/A	Flare Type LT	N/A	N/A	Flare Type RT	N/A
N/A	Flare Slope LT (%)	N/A	N/A	Flare Slope RT (%)	N/A
N/A	Flare Traversable LT?	N/A	N/A	Flare Traversable RT?	N/A
N/A	Landing Length (in)	N/A	N/A	DWS Provided?	N/A
N/A	Landing Width (in)	N/A	N/A	DWS Contrast?	N/A
N/A	Landing Slope (%)	N/A	N/A	DWS Length (in)	N/A
N/A	Landing X Slope (%)	N/A	N/A	DWS Full Width?	N/A
N/A	Landing Curb? (Y/N)	N/A	N/A	DWS Offset (in)	N/A
N/A	Shared Landing?	N/A			
N/A	Gutter Ponding?	N/A	N/A	Gutter Slope (%)	N/A
N/A	Gutter Lip Ht (in)	N/A	N/A	Gutter X Slope (%)	N/A
N/A	Painted X Walk1?	Yes	N/A	Painted X Walk2?	N/A
	X Walk 1 Direction	To SE		X Walk 2 Direction	N/A
N/A	X Walk 1 Width (in)	100.0	N/A	X Walk 2 Width (in)	N/A
	X Walk 1 Slope (%)	3.5		X Walk 2 Slope (%)	N/A
	X Walk 1 X Slope (%)	1.0		X Walk 2 X Slope (%)	N/A

N/A	Ramp inside XWalk1?	Yes	N/A	Ramp inside XWalk2?	N/A
	Road Slope (%)	N/A	N/A	Clear Space?	N/A
	Road X Slope (%)	N/A	N/A	Clear Space to XWalk (in)	N/A
N/A	Any Obstructions?	N/A	N/A	Storm Grate/Utility Hazard?	N/A
	Obstruction Type			Storm Grate/Utility Type	
		N/A			N/A
			Yes	Surface Condition? (G/P)	Good

Remove & Replace Entire Ramp.
