# Access Compliance Report

## Public Rights-of-Way

### (Curb Ramps)

Intersection ID: 8047	Main Street: N_HOSKINS_RD	Cross Street: ROZZELLES_FERRY_RD	Location: E
ADA ID: 747426FEA428	Ramp Type: Perp	Initial Pass/Fail: Fail	Overall Compliance: No
Codes/Mitigation Info/Possible Solution		Field Measurements/Component Compliance	
Severity Score: 21.25

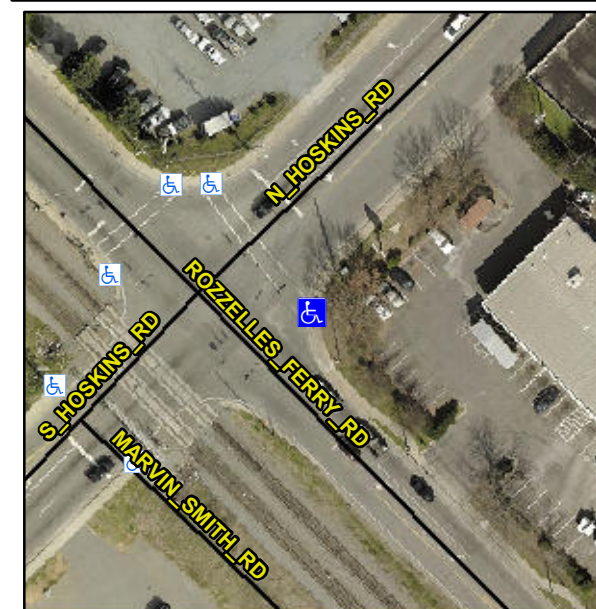
**Not Found, R304.5.1, R304.2.2**

Compliance	Description	Data	Compliance	Description	Data
N/A	Ramp Length (in)	62.0	No	Ramp Slope (%)	9.7
No	Ramp Width (in)	45.0	Yes	Ramp XSlope (%)	0.7
N/A	Flare Type LT	N/A	N/A	Flare Type RT	N/A
N/A	Flare Slope LT (%)	N/A	N/A	Flare Slope RT (%)	N/A
N/A	Flare Traversable LT?	N/A	N/A	Flare Traversable RT?	N/A
N/A	Landing Length (in)	N/A	N/A	DWS Provided?	N/A
N/A	Landing Width (in)	N/A	N/A	DWS Contrast?	N/A
N/A	Landing Slope (%)	N/A	N/A	DWS Length (in)	N/A
N/A	Landing X Slope (%)	N/A	N/A	DWS Full Width?	N/A
N/A	Landing Curb? (Y/N)	N/A	N/A	DWS Offset (in)	N/A
N/A	Shared Landing?	N/A			
N/A	Gutter Ponding?	N/A	N/A	Gutter Slope (%)	N/A
N/A	Gutter Lip Ht (in)	N/A	N/A	Gutter X Slope (%)	N/A
N/A	Painted X Walk1?	No	N/A	Painted X Walk2?	N/A
	X Walk 1 Direction	To N		X Walk 2 Direction	N/A
N/A	X Walk 1 Width (in)	N/A	N/A	X Walk 2 Width (in)	N/A
	X Walk 1 Slope (%)	2.3		X Walk 2 Slope (%)	N/A
	X Walk 1 X Slope (%)	1.5		X Walk 2 X Slope (%)	N/A

N/A	Ramp inside XWalk1?	N/A	N/A	Ramp inside XWalk2?	N/A
	Road Slope (%)	N/A	N/A	Clear Space?	N/A
	Road X Slope (%)	N/A	N/A	Clear Space to XWalk (in)	N/A
N/A	Any Obstructions?	N/A	N/A	Storm Grate/Utility Hazard?	N/A
	Obstruction Type			Storm Grate/Utility Type	
		N/A			N/A
			Yes	Surface Condition? (G/P)	Good

**Remove & Replace Entire Ramp.**

Total Cost: \$ 1850.00
