Access Compliance Report

Public Rights-of-Way

(Curb Ramps)

Intersection ID: 3145	Main Street: BASKERVILLE_AV	Cross Street: PALLADIUM_PL	Location: S
ADA ID: 7476084B3F64	Ramp Type: Perp	Initial Pass/Fail: Fail	Overall Compliance: No
Severity Score: 12.5			
Codes/Mitigation Info/Possible Solution		Field Measurements/Component Compliance

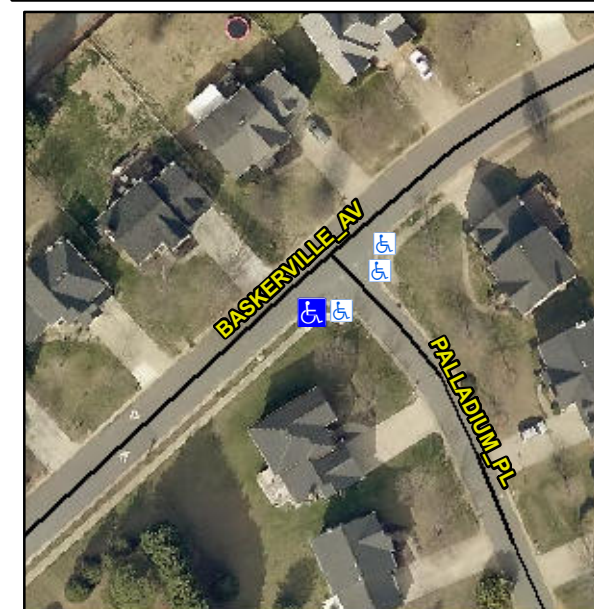
Not Found, R304.2.2

Compliance	Description	Data	Compliance	Description	Data
N/A	Ramp Length (in)	46.0	No	Ramp Slope (%)	9.1
Yes	Ramp Width (in)	64.0	Yes	Ramp XSlope (%)	0.2
N/A	Flare Type LT	N/A	N/A	Flare Type RT	N/A
N/A	Flare Slope LT (%)	N/A	N/A	Flare Slope RT (%)	N/A
N/A	Flare Traversable LT?	N/A	N/A	Flare Traversable RT?	N/A
N/A	Landing Length (in)	N/A	N/A	DWS Provided?	N/A
N/A	Landing Width (in)	N/A	N/A	DWS Contrast?	N/A
N/A	Landing Slope (%)	N/A	N/A	DWS Length (in)	N/A
N/A	Landing X Slope (%)	N/A	N/A	DWS Full Width?	N/A
N/A	Landing Curb? (Y/N)	N/A	N/A	DWS Offset (in)	N/A
N/A	Shared Landing?	N/A			
N/A	Gutter Ponding?	N/A	N/A	Gutter Slope (%)	N/A
N/A	Gutter Lip Ht (in)	N/A	N/A	Gutter X Slope (%)	N/A
N/A	Painted X Walk1?	No	N/A	Painted X Walk2?	N/A
	X Walk 1 Direction	To NW		X Walk 2 Direction	N/A
N/A	X Walk 1 Width (in)	N/A	N/A	X Walk 2 Width (in)	N/A
	X Walk 1 Slope (%)	5.0		X Walk 2 Slope (%)	N/A
	X Walk 1 X Slope (%)	0.4		X Walk 2 X Slope (%)	N/A

Remove & Replace Entire Ramp.

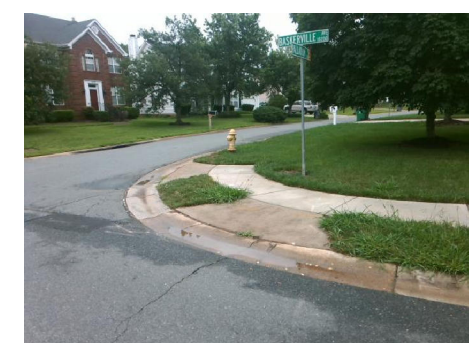
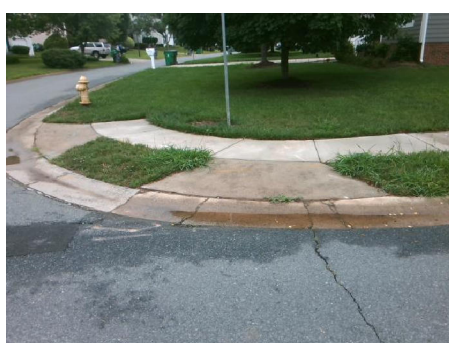
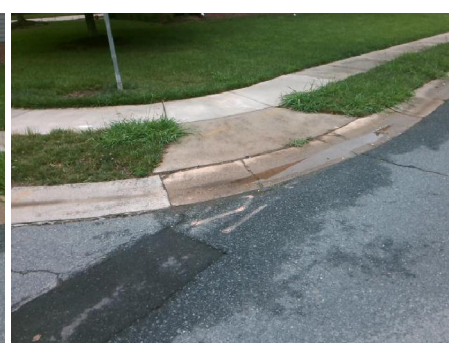
N/A	Ramp inside XWalk1?	N/A	N/A	Ramp inside XWalk2?	N/A
	Road Slope (%)	N/A	N/A	Clear Space?	N/A
	Road X Slope (%)	N/A	N/A	Clear Space to XWalk (in)	N/A
N/A	Any Obstructions?	N/A	N/A	Storm Grate/Utility Hazard?	N/A
	Obstruction Type			Storm Grate/Utility Type	
		N/A			N/A
			Yes	Surface Condition? (G/P)	Good
