Access Compliance Report

Public Rights-of-Way

(Curb Ramps)

Intersection ID: 9768	Main Street: EASTWAY_DR	Cross Street: THE_PLAZA	Location: SW
ADA ID: 74776DA02E8C	Ramp Type: PerpDiag	Initial Pass/Fail: Fail	Overall Compliance: No
Severity Score: 22.5			
Codes/Mitigation Info/Possible Solution		Field Measurements/Component Compliance

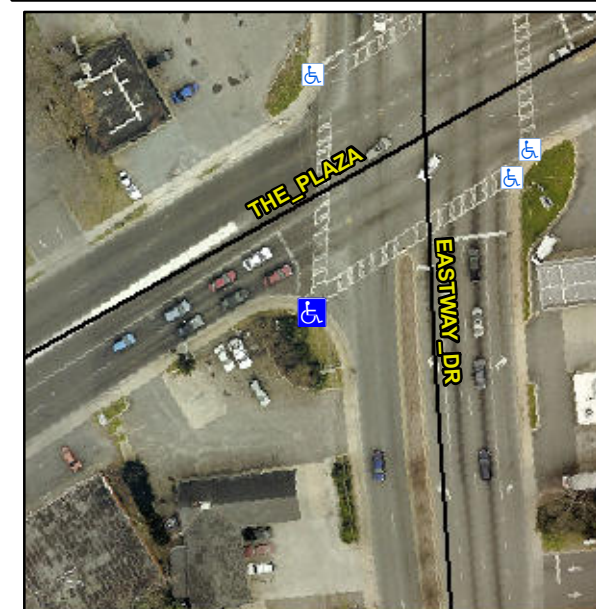
Not Found, R304.5.1, R304.2.2, R304.5.3

Compliance	Description	Data	Compliance	Description	Data
N/A	Ramp Length (in)	58.5	No	Ramp Slope (%)	11.1
No	Ramp Width (in)	46.5	No	Ramp XSlope (%)	4.5
N/A	Flare Type LT	N/A	N/A	Flare Type RT	N/A
N/A	Flare Slope LT (%)	N/A	N/A	Flare Slope RT (%)	N/A
N/A	Flare Traversable LT?	N/A	N/A	Flare Traversable RT?	N/A
N/A	Landing Length (in)	N/A	N/A	DWS Provided?	N/A
N/A	Landing Width (in)	N/A	N/A	DWS Contrast?	N/A
N/A	Landing Slope (%)	N/A	N/A	DWS Length (in)	N/A
N/A	Landing X Slope (%)	N/A	N/A	DWS Full Width?	N/A
N/A	Landing Curb? (Y/N)	N/A	N/A	DWS Offset (in)	N/A
N/A	Shared Landing?	N/A			
N/A	Gutter Ponding?	N/A	N/A	Gutter Slope (%)	N/A
N/A	Gutter Lip Ht (in)	N/A	N/A	Gutter X Slope (%)	N/A
N/A	Painted X Walk1?	Yes	N/A	Painted X Walk2?	Yes
	X Walk 1 Direction	To NE		X Walk 2 Direction	To N
N/A	X Walk 1 Width (in)	82.5	N/A	X Walk 2 Width (in)	80.0
	X Walk 1 Slope (%)	0.2		X Walk 2 Slope (%)	0.8
	X Walk 1 X Slope (%)	0.1		X Walk 2 X Slope (%)	2.1

N/A	Ramp inside XWalk1?	No	N/A	Ramp inside XWalk2?	Yes
	Road Slope (%)	1.9	N/A	Clear Space?	N/A
	Road X Slope (%)	1.1	N/A	Clear Space to XWalk (in)	N/A
N/A	Any Obstructions?	N/A	N/A	Storm Grate/Utility Hazard?	N/A
	Obstruction Type			Storm Grate/Utility Type	
		N/A			N/A
		Yes		Surface Condition? (G/P)	Good

Remove & Replace Curb Ramp With Two New Directional Ramps or Equivalent. Restripe Crosswalk.
