## **Access Compliance Report Public Rights-of-Way** (Curb Ramps)

Intersection ID: 14024 Main Street: BASCOM ST **Cross Street: CHESTERFIELD AV** Location: Ν **Overall Compliance: No Severity Score:** ADA ID: 7486CB004A50 Ramp Type: PerpDiag Initial Pass/Fail: Fail 8.75

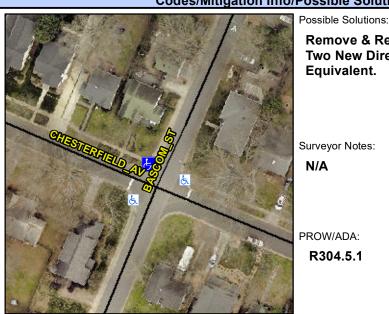
Street 1 Name Stop Condition-Street 2 Street 2 Name Stop Condition-Street 1 Surveyor Notes: N/A PROW/ADA: R304.5.1

Equivalent.

> Total Cost: 3200.00

Remove & Replace Curb Ramp With Two New Directional Ramps or
