# Access Compliance Report

## Public Rights-of-Way

### (Curb Ramps)

Intersection ID: 52441	Main Street: WOODWARD_AV	Cross Street: BENDING_BIRCH_PL	Location: SE
ADA ID: 748C95C156D9	Ramp Type: Perp	Initial Pass/Fail: Pass	Overall Compliance: No
Severity Score: 30.25			
Codes/Mitigation Info/Possible Solution		Field Measurements/Component Compliance

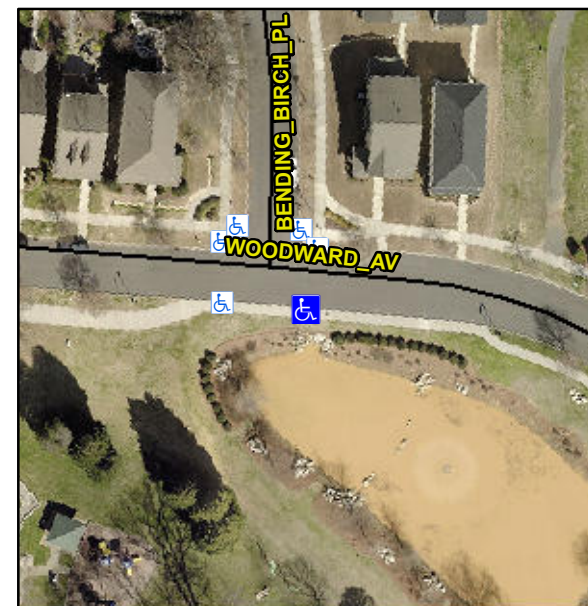
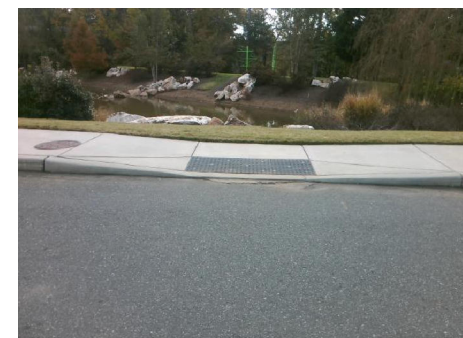
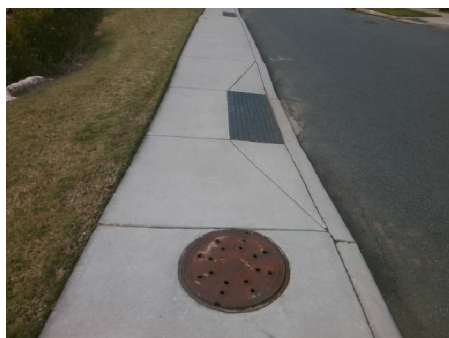
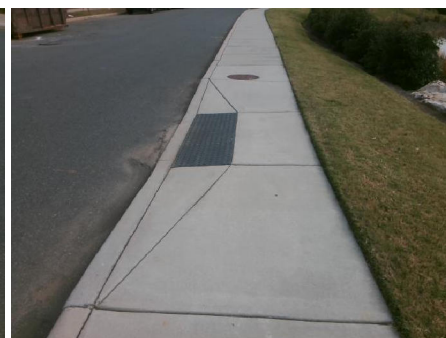
Compliance	Description	Data	Compliance	Description	Data
N/A	Ramp Length (in)	60.5	Yes	Ramp Slope (%)	7.7
Yes	Ramp Width (in)	72.0	No	Ramp XSlope (%)	2.4
N/A	Flare Type LT	Sloped	N/A	Flare Type RT	N/A
N/A	Flare Slope LT (%)	10.2	N/A	Flare Slope RT (%)	3.9
N/A	Flare Traversable LT?	No	N/A	Flare Traversable RT?	No
No	Landing Length (in)	N/A	Yes	DWS Provided?	Yes
No	Landing Width (in)	N/A	Yes	DWS Contrast?	Yes
No	Landing Slope (%)	N/A	Yes	DWS Length (in)	24.0
No	Landing X Slope (%)	N/A	Yes	DWS Full Width?	Yes
N/A	Landing Curb? (Y/N)	No	Yes	DWS Offset (in)	0.0
N/A	Shared Landing?	No			
Yes	Gutter Ponding?	No	No	Gutter Slope (%)	6.5
No	Gutter Lip Ht (in)	1.0	Yes	Gutter X Slope (%)	2.2
N/A	Painted X Walk1?	No	N/A	Painted X Walk2?	N/A
	X Walk 1 Direction	To N		X Walk 2 Direction	N/A
N/A	X Walk 1 Width (in)	N/A	N/A	X Walk 2 Width (in)	N/A
	X Walk 1 Slope (%)	4.5		X Walk 2 Slope (%)	N/A
	X Walk 1 X Slope (%)	2.2		X Walk 2 X Slope (%)	N/A

N/A	Ramp inside XWalk1?	N/A	N/A	Ramp inside XWalk2?	N/A
	Road Slope (%)	N/A	N/A	Clear Space?	Yes
	Road X Slope (%)	N/A	N/A	Clear Space to XWalk (in)	N/A
Yes	Any Obstructions?	No	Yes	Storm Grate/Utility Hazard?	No
	Obstruction Type			Storm Grate/Utility Type	
		N/A			N/A
			Yes	Surface Condition? (G/P)	Good

Possible Solutions:

**Remove & Replace Entire Ramp.  
Remove & Replace Gutter.**
