Access Compliance Report

Public Rights-of-Way

| Intersection ID: 10037302 | Main Street: SARDIS_RD | Cross Street: N/A | Location: NE |
| ADA ID: 7495E70D0BEC | Ramp Type: BlendTrans1 | Initial Pass/Fail: Fail | Overall Compliance: No |

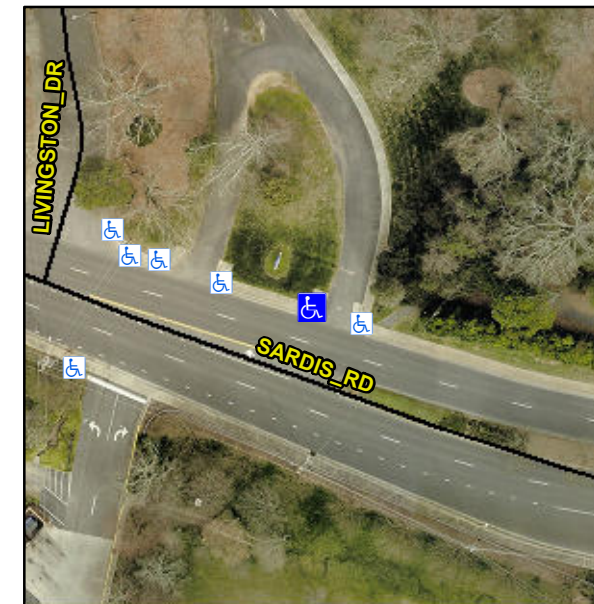
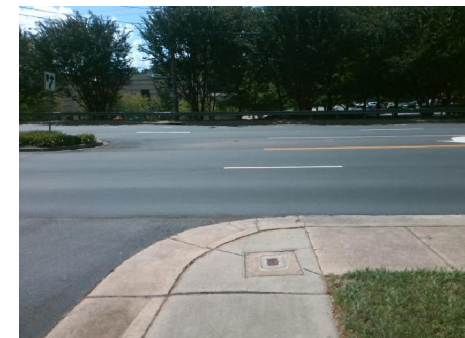
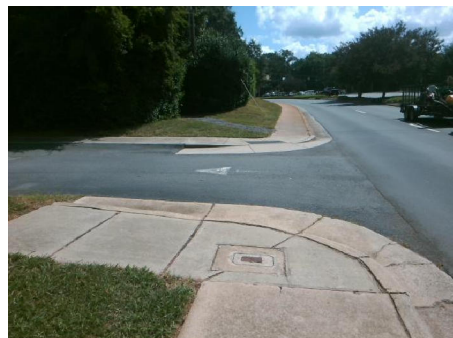
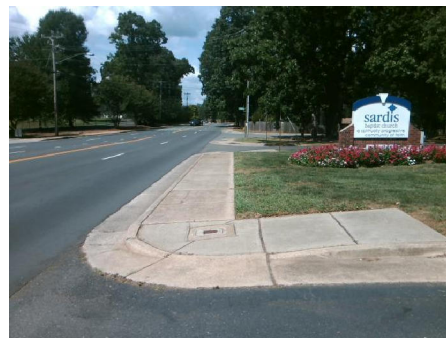
| | | | Severity Score: 21.25 |

R304.5.1, R304.5.3

| Compliance | Description | Data | Compliance | Description | Data |
|---|---|---|---|---|---|
| No | Ramp Width (in) | 37.0 | No | BlendTrans XSlope (%) | 6.4 |

Remove & Replace Curb Ramp With Two New Directional Ramps or Equivalent.

Total Cost: \$ 3200.00
