Access Compliance Report

Public Rights-of-Way

(Curb Ramps)

Intersection ID: 53404	Main Street: MAIN_ST	Cross Street: MORGAN_PARK_DR	Location: SE
ADA ID: 74A2CD5F97AE	Ramp Type: PerpDiag	Initial Pass/Fail: Fail	Overall Compliance: No
Severity Score: 36.25			
Codes/Mitigation Info/Possible Solution		Field Measurements/Component Compliance

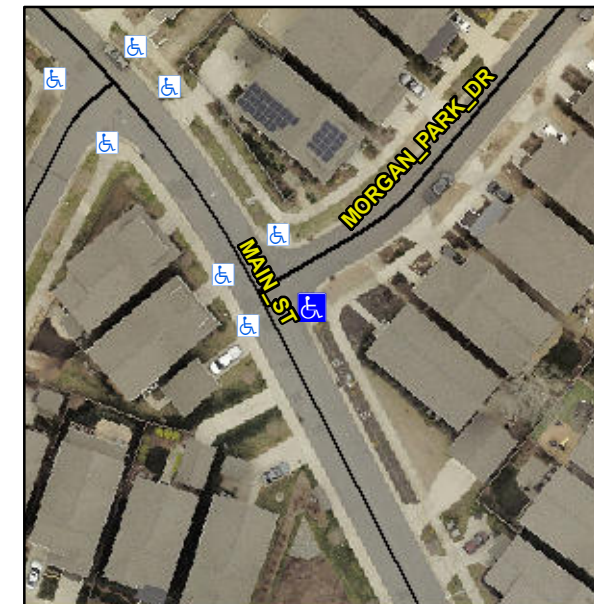
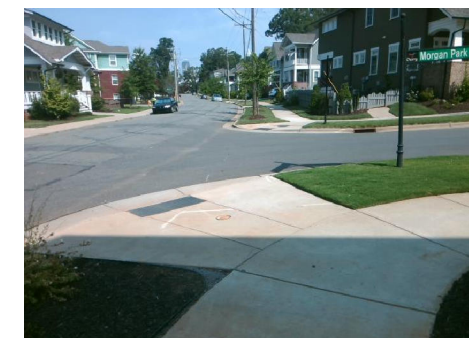
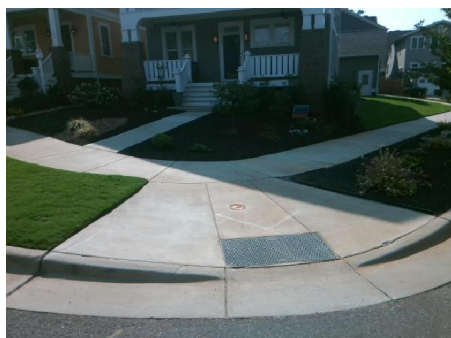
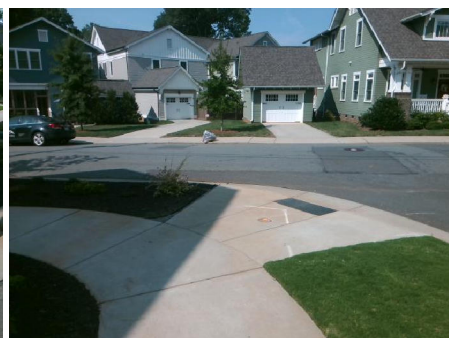
Not Found, R304.5.1, R304.5.3

Compliance	Description	Data	Compliance	Description	Data
N/A	Ramp Length (in)	116.0	Yes	Ramp Slope (%)	5.1
No	Ramp Width (in)	30.5	No	Ramp XSlope (%)	3.0
N/A	Flare Type LT	N/A	N/A	Flare Type RT	N/A
N/A	Flare Slope LT (%)	N/A	N/A	Flare Slope RT (%)	N/A
N/A	Flare Traversable LT?	N/A	N/A	Flare Traversable RT?	N/A
N/A	Landing Length (in)	N/A	N/A	DWS Provided?	N/A
N/A	Landing Width (in)	N/A	N/A	DWS Contrast?	N/A
N/A	Landing Slope (%)	N/A	N/A	DWS Length (in)	N/A
N/A	Landing X Slope (%)	N/A	N/A	DWS Full Width?	N/A
N/A	Landing Curb? (Y/N)	N/A	N/A	DWS Offset (in)	N/A
N/A	Shared Landing?	N/A			
N/A	Gutter Ponding?	N/A	N/A	Gutter Slope (%)	N/A
N/A	Gutter Lip Ht (in)	N/A	N/A	Gutter X Slope (%)	N/A
N/A	Painted X Walk1?	No	N/A	Painted X Walk2?	No
	X Walk 1 Direction	To N		X Walk 2 Direction	To W
N/A	X Walk 1 Width (in)	N/A	N/A	X Walk 2 Width (in)	N/A
	X Walk 1 Slope (%)	3.4		X Walk 2 Slope (%)	2.3
	X Walk 1 X Slope (%)	1.8		X Walk 2 X Slope (%)	0.2

N/A	Ramp inside XWalk1?	N/A	N/A	Ramp inside XWalk2?	N/A
	Road Slope (%)	1.5	N/A	Clear Space?	N/A
	Road X Slope (%)	2.2	N/A	Clear Space to XWalk (in)	N/A
N/A	Any Obstructions?	N/A	N/A	Storm Grate/Utility Hazard?	N/A
	Obstruction Type			Storm Grate/Utility Type	
		N/A			N/A
		Yes		Surface Condition? (G/P)	Good

Remove & Replace Curb Ramp With Two New Directional Ramps or Equivalent.
