Access Compliance Report

Public Rights-of-Way

(Curb Ramps)

Intersection ID: 50401	Main Street: DEBORAH_DR	Cross Street: WILSON_DR	Location:	E
ADA ID: 74B35241C0D5	Ramp Type: Perp	Initial Pass/Fail: Fail	Overall Compliance: No	Severity Score: 22.5
Codes/Mitigation Info/Possible Solution		Field Measurements/Component Compliance

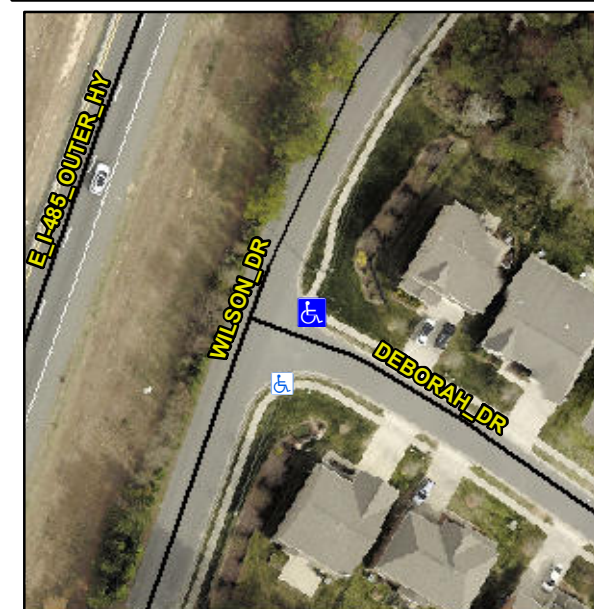
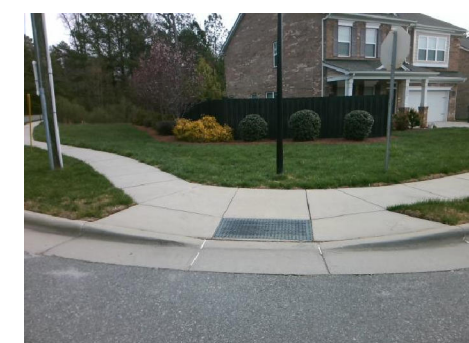
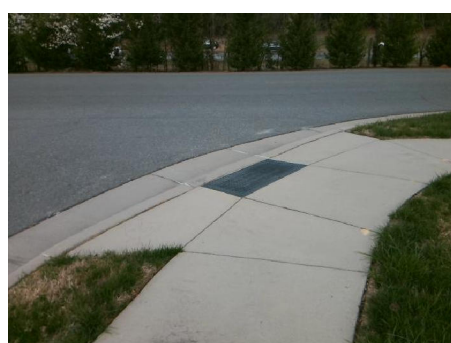
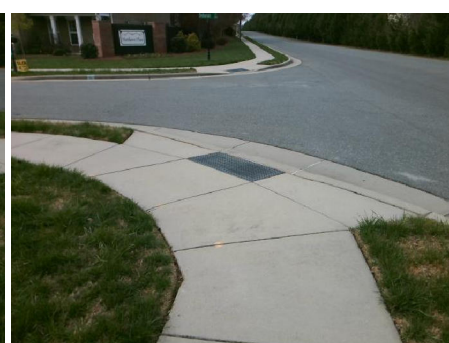
Not Found, R304.5.1, R304.2.2, R304.5.3

Compliance	Description	Data	Compliance	Description	Data
N/A	Ramp Length (in)	79.0	No	Ramp Slope (%)	9.5
No	Ramp Width (in)	47.5	No	Ramp XSlope (%)	2.6
N/A	Flare Type LT	N/A	N/A	Flare Type RT	N/A
N/A	Flare Slope LT (%)	N/A	N/A	Flare Slope RT (%)	N/A
N/A	Flare Traversable LT?	N/A	N/A	Flare Traversable RT?	N/A
N/A	Landing Length (in)	N/A	N/A	DWS Provided?	N/A
N/A	Landing Width (in)	N/A	N/A	DWS Contrast?	N/A
N/A	Landing Slope (%)	N/A	N/A	DWS Length (in)	N/A
N/A	Landing X Slope (%)	N/A	N/A	DWS Full Width?	N/A
N/A	Landing Curb? (Y/N)	N/A	N/A	DWS Offset (in)	N/A
N/A	Shared Landing?	N/A			
N/A	Gutter Ponding?	N/A	N/A	Gutter Slope (%)	N/A
N/A	Gutter Lip Ht (in)	N/A	N/A	Gutter X Slope (%)	N/A
N/A	Painted X Walk1?	No	N/A	Painted X Walk2?	N/A
	X Walk 1 Direction	To SW		X Walk 2 Direction	N/A
N/A	X Walk 1 Width (in)	N/A	N/A	X Walk 2 Width (in)	N/A
	X Walk 1 Slope (%)	0.3		X Walk 2 Slope (%)	N/A
	X Walk 1 X Slope (%)	3.4		X Walk 2 X Slope (%)	N/A

N/A	Ramp inside XWalk1?	N/A	N/A	Ramp inside XWalk2?	N/A
	Road Slope (%)	N/A	N/A	Clear Space?	N/A
	Road X Slope (%)	N/A	N/A	Clear Space to XWalk (in)	N/A
N/A	Any Obstructions?	N/A	N/A	Storm Grate/Utility Hazard?	N/A
	Obstruction Type			Storm Grate/Utility Type	
		N/A			N/A
			Yes	Surface Condition? (G/P)	Good

Possible Solutions:

Remove & Replace Entire Ramp.
