Access Compliance Report

Public Rights-of-Way

(Curb Ramps)

Intersection ID: 11472	Main Street: FARM_GATE_DR	Cross Street: WILLIAMS_RD	Location: W
ADA ID: 74BFE71B7DC8	Ramp Type: Perp	Initial Pass/Fail: Fail	Overall Compliance: No
Severity Score: 37.5			
Codes/Mitigation Info/Possible Solution		Field Measurements/Component Compliance

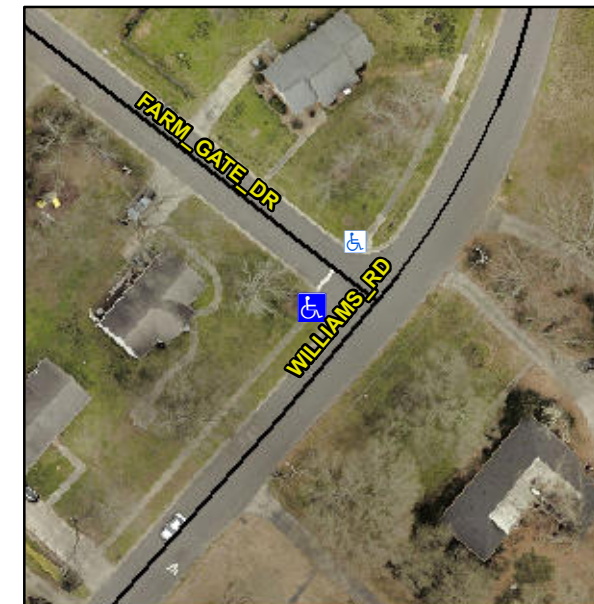
Not Found, R304.2.2, R304.5.3

Compliance	Description	Data	Compliance	Description	Data
N/A	Ramp Length (in)	76.5	No	Ramp Slope (%)	8.8
Yes	Ramp Width (in)	48.0	No	Ramp XSlope (%)	8.7
N/A	Flare Type LT	N/A	N/A	Flare Type RT	N/A
N/A	Flare Slope LT (%)	N/A	N/A	Flare Slope RT (%)	N/A
N/A	Flare Traversable LT?	N/A	N/A	Flare Traversable RT?	N/A
N/A	Landing Length (in)	N/A	N/A	DWS Provided?	N/A
N/A	Landing Width (in)	N/A	N/A	DWS Contrast?	N/A
N/A	Landing Slope (%)	N/A	N/A	DWS Length (in)	N/A
N/A	Landing X Slope (%)	N/A	N/A	DWS Full Width?	N/A
N/A	Landing Curb? (Y/N)	N/A	N/A	DWS Offset (in)	N/A
N/A	Shared Landing?	N/A			
N/A	Gutter Ponding?	N/A	N/A	Gutter Slope (%)	N/A
N/A	Gutter Lip Ht (in)	1.0	N/A	Gutter X Slope (%)	N/A
N/A	Painted X Walk1?	No	N/A	Painted X Walk2?	N/A
	X Walk 1 Direction	To NE		X Walk 2 Direction	N/A
N/A	X Walk 1 Width (in)	N/A	N/A	X Walk 2 Width (in)	N/A
	X Walk 1 Slope (%)	1.6		X Walk 2 Slope (%)	N/A
	X Walk 1 X Slope (%)	3.2		X Walk 2 X Slope (%)	N/A

N/A	Ramp inside XWalk1?	N/A	N/A	Ramp inside XWalk2?	N/A
	Road Slope (%)	N/A	N/A	Clear Space?	N/A
	Road X Slope (%)	N/A	N/A	Clear Space to XWalk (in)	N/A
N/A	Any Obstructions?	N/A	N/A	Storm Grate/Utility Hazard?	N/A
	Obstruction Type			Storm Grate/Utility Type	
		N/A			N/A
			Yes	Surface Condition? (G/P)	Good

Remove & Replace Entire Ramp.
