# Access Compliance Report

## Public Rights-of-Way

| Intersection ID: 13833 | Main Street: WEST_BV | Cross Street: WALTON_RD | Location: NE |
| ADA ID: 74CC9AB26AD6 | Ramp Type: PerpDiag | Initial Pass/Fail: Pass | Overall Compliance: No |

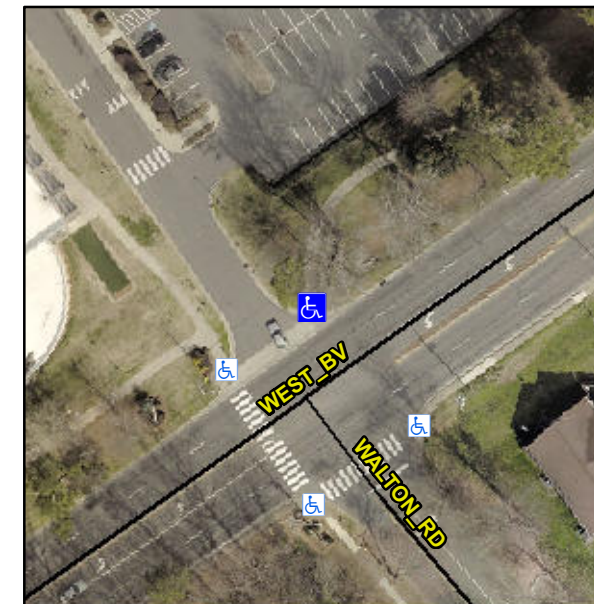
| | | Severity Score: 7.5 | |

| Compliance | Description | Data | Compliance | Description | Data |
|---|---|---|---|---|---|
| No | Landing Width (in) | 47.0 | Yes | DWS Contrast? | Yes |
| No | Landing Slope (%) | 2.5 | Yes | DWS Length (in) | 24.0 |
| No | Gutter Lip Ht (in) | 0.5 | No | Gutter X Slope (%) | 2.5 |

**Remove & Replace Landing.  
Remove & Replace Gutter.**

**R304.2.1, R304.2.2-Perp, R304.3.2-  
Para, R302.7.2, R304.5.3**
