# Access Compliance Report

## Public Rights-of-Way

### (Curb Ramps)

Intersection ID: 23415	Main Street: ENGLISH_MEADOWS_LN	Cross Street: OLD_PROVIDENCE_RD	Location: S
ADA ID: 74E8D346AAF7	Ramp Type: Perp	Initial Pass/Fail: Fail	Overall Compliance: No
		Severity Score: 12.5

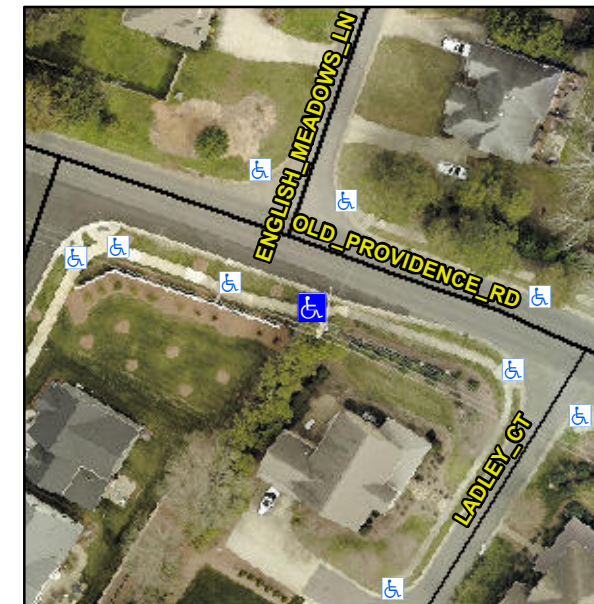
**Not Found, R304.2.2**

Compliance	Description	Data	Compliance	Description	Data
N/A	Ramp Length (in)	78.0	No	Ramp Slope (%)	11.4
Yes	Ramp Width (in)	48.0	Yes	Ramp XSlope (%)	0.2
N/A	Flare Type LT	N/A	N/A	Flare Type RT	N/A
N/A	Flare Slope LT (%)	N/A	N/A	Flare Slope RT (%)	N/A
N/A	Flare Traversable LT?	N/A	N/A	Flare Traversable RT?	N/A
N/A	Landing Length (in)	N/A	N/A	DWS Provided?	N/A
N/A	Landing Width (in)	N/A	N/A	DWS Contrast?	N/A
N/A	Landing Slope (%)	N/A	N/A	DWS Length (in)	N/A
N/A	Landing X Slope (%)	N/A	N/A	DWS Full Width?	N/A
N/A	Landing Curb? (Y/N)	N/A	N/A	DWS Offset (in)	N/A
N/A	Shared Landing?	N/A			
N/A	Gutter Ponding?	N/A	N/A	Gutter Slope (%)	N/A
N/A	Gutter Lip Ht (in)	1.0	N/A	Gutter X Slope (%)	N/A
N/A	Painted X Walk1?	No	N/A	Painted X Walk2?	N/A
	X Walk 1 Direction	To NE		X Walk 2 Direction	N/A
N/A	X Walk 1 Width (in)	N/A	N/A	X Walk 2 Width (in)	N/A
	X Walk 1 Slope (%)	2.0		X Walk 2 Slope (%)	N/A
	X Walk 1 X Slope (%)	1.3		X Walk 2 X Slope (%)	N/A

**Remove & Replace Entire Ramp.**
