Access Compliance Report

Public Rights-of-Way

(Curb Ramps)

Intersection ID: 18189	Main Street: S_WENDOVER_RD	Cross Street: FOREST_DR	Location: SE
ADA ID: 74E9422B0B27	Ramp Type: PerpDiag	Initial Pass/Fail: Fail	Overall Compliance: No
Severity Score: 12.5			
Codes/Mitigation Info/Possible Solution		Field Measurements/Component Compliance

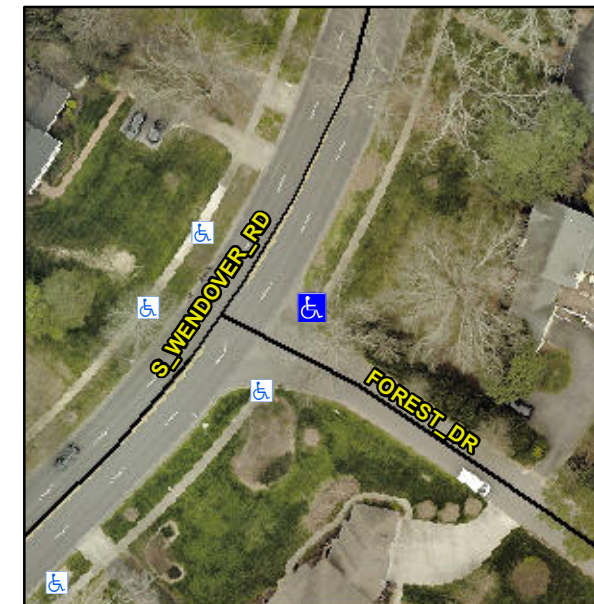
Not Found, R304.2.2

Compliance	Description	Data	Compliance	Description	Data
N/A	Ramp Length (in)	62.0	No	Ramp Slope (%)	8.4
Yes	Ramp Width (in)	48.0	Yes	Ramp XSlope (%)	0.8
N/A	Flare Type LT	N/A	N/A	Flare Type RT	N/A
N/A	Flare Slope LT (%)	N/A	N/A	Flare Slope RT (%)	N/A
N/A	Flare Traversable LT?	N/A	N/A	Flare Traversable RT?	N/A
N/A	Landing Length (in)	N/A	N/A	DWS Provided?	N/A
N/A	Landing Width (in)	N/A	N/A	DWS Contrast?	N/A
N/A	Landing Slope (%)	N/A	N/A	DWS Length (in)	N/A
N/A	Landing X Slope (%)	N/A	N/A	DWS Full Width?	N/A
N/A	Landing Curb? (Y/N)	N/A	N/A	DWS Offset (in)	N/A
N/A	Shared Landing?	N/A			
N/A	Gutter Ponding?	N/A	N/A	Gutter Slope (%)	N/A
N/A	Gutter Lip Ht (in)	N/A	N/A	Gutter X Slope (%)	N/A
N/A	Painted X Walk1?	No	N/A	Painted X Walk2?	No
	X Walk 1 Direction	To NE		X Walk 2 Direction	To SW
N/A	X Walk 1 Width (in)	N/A	N/A	X Walk 2 Width (in)	N/A
	X Walk 1 Slope (%)	7.7		X Walk 2 Slope (%)	5.2
	X Walk 1 X Slope (%)	2.4		X Walk 2 X Slope (%)	7.6

N/A	Ramp inside XWalk1?	N/A	N/A	Ramp inside XWalk2?	N/A
	Road Slope (%)	2.0	N/A	Clear Space?	N/A
	Road X Slope (%)	7.9	N/A	Clear Space to XWalk (in)	N/A
N/A	Any Obstructions?	N/A	N/A	Storm Grate/Utility Hazard?	N/A
	Obstruction Type			Storm Grate/Utility Type	
		N/A			N/A
			Yes	Surface Condition? (G/P)	Good

Possible Solutions:

Remove & Replace Curb Ramp With Two New Directional Ramps or Equivalent.
