Access Compliance Report

Public Rights-of-Way

(Curb Ramps)

Intersection ID: 44685	Main Street: HARWOOD_HILLS_LN	Cross Street: HARWOOD_LN	Location: W
ADA ID: 74F6F85A7020	Ramp Type: Perp	Initial Pass/Fail: Fail	Overall Compliance: No
Severity Score: 33.75			
Codes/Mitigation Info/Possible Solution		Field Measurements/Component Compliance

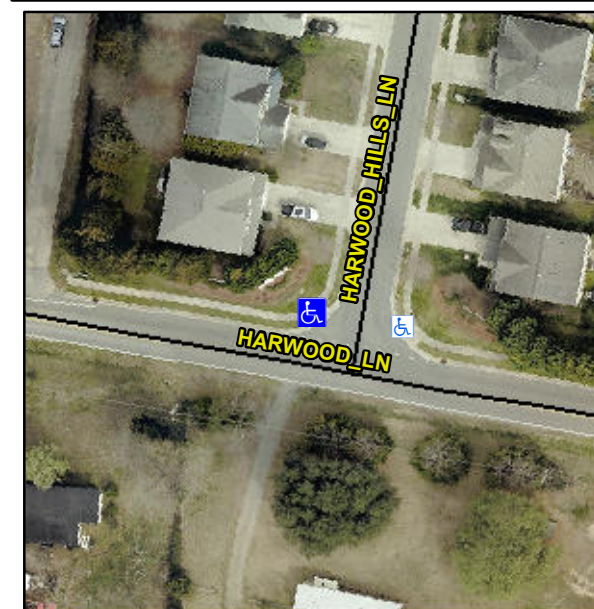
Not Found, R304.5.1, R304.2.2

Compliance	Description	Data	Compliance	Description	Data
N/A	Ramp Length (in)	49.0	No	Ramp Slope (%)	13.2
No	Ramp Width (in)	41.5	Yes	Ramp XSlope (%)	1.0
N/A	Flare Type LT	N/A	N/A	Flare Type RT	N/A
N/A	Flare Slope LT (%)	N/A	N/A	Flare Slope RT (%)	N/A
N/A	Flare Traversable LT?	N/A	N/A	Flare Traversable RT?	N/A
N/A	Landing Length (in)	N/A	N/A	DWS Provided?	N/A
N/A	Landing Width (in)	N/A	N/A	DWS Contrast?	N/A
N/A	Landing Slope (%)	N/A	N/A	DWS Length (in)	N/A
N/A	Landing X Slope (%)	N/A	N/A	DWS Full Width?	N/A
N/A	Landing Curb? (Y/N)	N/A	N/A	DWS Offset (in)	N/A
N/A	Shared Landing?	N/A			
N/A	Gutter Ponding?	N/A	N/A	Gutter Slope (%)	N/A
N/A	Gutter Lip Ht (in)	N/A	N/A	Gutter X Slope (%)	N/A
N/A	Painted X Walk1?	No	N/A	Painted X Walk2?	N/A
	X Walk 1 Direction	To E		X Walk 2 Direction	N/A
N/A	X Walk 1 Width (in)	N/A	N/A	X Walk 2 Width (in)	N/A
	X Walk 1 Slope (%)	4.0		X Walk 2 Slope (%)	N/A
	X Walk 1 X Slope (%)	1.4		X Walk 2 X Slope (%)	N/A

N/A	Ramp inside XWalk1?	N/A	N/A	Ramp inside XWalk2?	N/A
	Road Slope (%)	N/A	N/A	Clear Space?	N/A
	Road X Slope (%)	N/A	N/A	Clear Space to XWalk (in)	N/A
N/A	Any Obstructions?	N/A	N/A	Storm Grate/Utility Hazard?	N/A
	Obstruction Type			Storm Grate/Utility Type	
		N/A			N/A
		Yes		Surface Condition? (G/P)	Good

Remove & Replace Entire Ramp.
