## **Access Compliance Report Public Rights-of-Way** (Curb Ramps)

Intersection ID: 44242 Main Street: KIEV DR Cross Street: SUNSET\_RD Location: NW **Overall Compliance: No** ADA ID: 74FD654BF557 Ramp Type: Perp Initial Pass/Fail: Fail Severity Score: 21.25

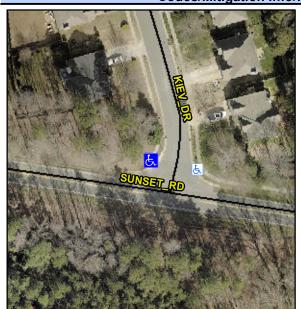
Field Measurements/Component Compliance								
Compl	iance Description	Data	Compl	iance	Description	Data		
N/A	Ramp Length (in)	48.0	No	Ram	Slope (%)	8.7		
No	Ramp Width (in)	42.0	Yes	Ramp	XSlope (%)	0.4		
N/A	Flare Type LT	N/A	N/A	Flare	Type RT	N/A		
N/A	Flare Slope LT (%)	N/A	N/A	Flare	Slope RT (%)	N/A		
N/A	Flare Traversable LT?	N/A	N/A	Flare	Traversable RT?	N/A		
N/A	Landing Length (in)	N/A	N/A	DWS	Provided?	N/A		
N/A	Landing Width (in)	N/A	N/A	DWS	Contrast?	N/A		
N/A	Landing Slope (%)	N/A	N/A	DWS	Length (in)	N/A		
N/A	Landing X Slope (%)	N/A	N/A	DWS	Full Width?	N/A		
N/A	Landing Curb? (Y/N)	N/A	N/A	DWS	Offset (in)	N/A		
N/A	Shared Landing?	N/A						
N/A	Gutter Ponding?	N/A	N/A	Gutte	er Slope (%)	N/A		
N/A	Gutter Lip Ht (in)	N/A	N/A	Gutte	er X Slope (%)	N/A		
N/A	Painted X Walk1?	No	N/A	Paint	ed X Walk2?	N/A		
	X Walk 1 Direction	To E		X Wa	lk 2 Direction	N/A		
N/A	X Walk 1 Width (in)	N/A	N/A	X Wa	lk 2 Width (in)	N/A

X Walk 1 Slope (%)	1.9		X Wa	lk 2 Slope (%)	N/A		
	X Walk 1 X Slope (%)	0.2		X Wa	lk 2 X Slope (%)	N/A		
N/A	Ramp inside XWalk1?	N/A	N/A	Ram	o inside XWalk2?	N/A		
	Road Slope (%)	N/A	N/A	Clear	Space?	N/A		
	Road X Slope (%)	N/A	N/A	Clear	Space to XWalk (in)	N/A		
N/A	Any Obstructions?	N/A	N/A	Storn	n Grate/Utility Hazard?	N/A		
	Obstruction Type			Storn	n Grate/Utility Type			
		N/A				N/A		
			Yes	Surfa	ce Condition? (G/P)	Good		
	<b>建</b> 网络

Possible Solution	
Possible Solutions:	(
Remove & Replace Entire Ramp.	N
·	N
	N
	N
	N
	N
Surveyor Notes:	N
N/A	N
	N
	N
	N
PROW/ADA:	N
R304.5.1, R304.2.2	N
,	N
	1
