Access Compliance Report

Public Rights-of-Way

(Curb Ramps)

Intersection ID: 17088	Main Street: CRAIG_AV	Cross Street: LOMAX_AV	Location:	N
ADA ID: 7504674A226F	Ramp Type: Para	Initial Pass/Fail: Fail	Overall Compliance: No	Severity Score: 25

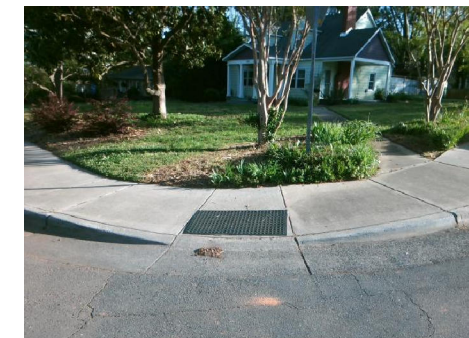
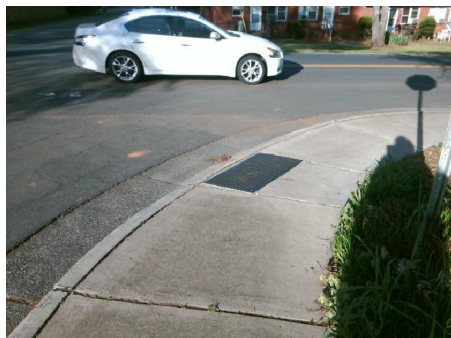
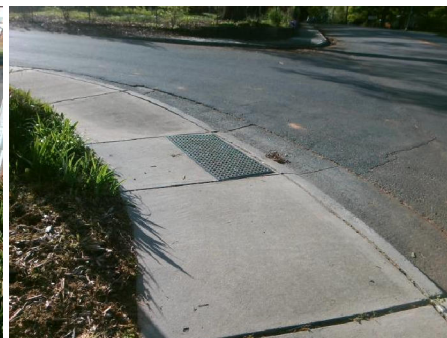
LT RP < 5%

Compliance	Description	Data	Compliance	Description	Data
N/A	Ramp Length LT (in)	58.0	N/A	Ramp Length RT (in)	59.0
Yes	Ramp Width LT (in)	59.0	Yes	Ramp Width RT (in)	59.0
Yes	Ramp Slope LT (%)	2.7	No	Ramp Slope RT (%)	11.9
No	Ramp XSlope LT (%)	5.5	No	Ramp XSlope RT (%)	4.6
N/A	Landing Length (in)	N/A	N/A	DWS Provided?	N/A
N/A	Landing Width (in)	N/A	N/A	DWS Contrast?	N/A
N/A	Landing Slope (%)	N/A	N/A	DWS Length (in)	N/A
N/A	Landing X Slope (%)	N/A	N/A	DWS Full Width?	N/A
N/A	Landing Curb? (Y/N)	N/A	N/A	DWS Offset (in)	N/A
N/A	Shared Landing?	N/A			
N/A	Gutter Ponding?	N/A	N/A	Gutter Slope (%)	N/A
N/A	Gutter Lip Ht (in)	N/A	N/A	Gutter X Slope (%)	N/A
N/A	Painted X Walk1?	No	N/A	Painted X Walk2?	N/A
	X Walk 1 Direction	To SE		X Walk 2 Direction	N/A
N/A	X Walk 1 Width (in)	N/A	N/A	X Walk 2 Width (in)	N/A
	X Walk 1 Slope (%)	7.5		X Walk 2 Slope (%)	N/A
	X Walk 1 X Slope (%)	3.5		X Walk 2 X Slope (%)	N/A
N/A	Ramp inside XWalk1?	N/A	N/A	Ramp inside XWalk2?	N/A

Road Slope (%)	N/A	N/A	Clear Space?	N/A
	Road X Slope (%)	N/A	N/A	Clear Space to XWalk (in)	N/A
N/A	Any Obstructions?	N/A	N/A	Storm Grate/Utility Hazard?	N/A
	Obstruction Type			Storm Grate/Utility Type	
		N/A			N/A
			Yes	Surface Condition? (G/P)	Good
			N/A	Curb Slope (%)	21.6

Remove & Replace Entire Ramp.
