Access Compliance Report

Public Rights-of-Way

Intersection ID: 18214	Main Street: FERNCLIFF_RD	Cross Street: PROVIDENCE_RD	Location: W
ADA ID: 750C6F04656D	Ramp Type: PerpDiag	Initial Pass/Fail: Fail	Overall Compliance: No
		Severity Score: 25

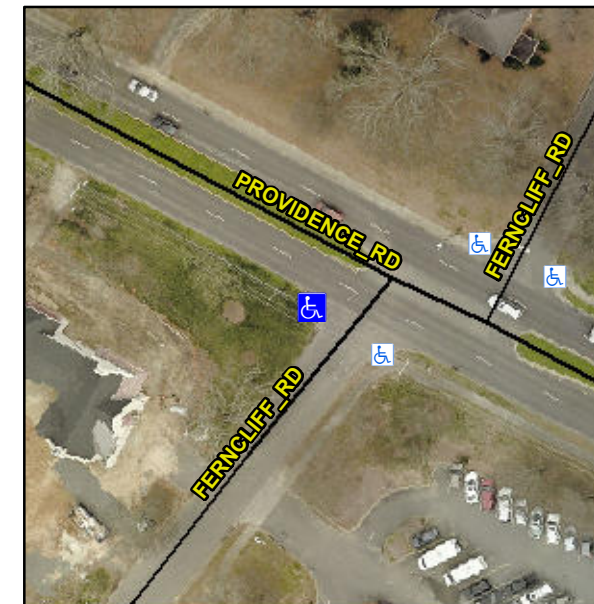
Not Found, R304.5.1, R304.5.3, R302.7

Compliance	Description	Data	Compliance	Description	Data
N/A	Ramp Length (in)	61.0	Yes	Ramp Slope (%)	7.6
No	Ramp Width (in)	39.0	No	Ramp XSlope (%)	2.5
N/A	Flare Type LT	N/A	N/A	Flare Type RT	N/A
N/A	Flare Slope LT (%)	N/A	N/A	Flare Slope RT (%)	N/A
N/A	Flare Traversable LT?	N/A	N/A	Flare Traversable RT?	N/A
N/A	Landing Length (in)	N/A	N/A	DWS Provided?	N/A
N/A	Landing Width (in)	N/A	N/A	DWS Contrast?	N/A
N/A	Landing Slope (%)	N/A	N/A	DWS Length (in)	N/A
N/A	Landing X Slope (%)	N/A	N/A	DWS Full Width?	N/A
N/A	Landing Curb? (Y/N)	N/A	N/A	DWS Offset (in)	N/A
N/A	Shared Landing?	N/A			
N/A	Gutter Ponding?	N/A	N/A	Gutter Slope (%)	N/A
N/A	Gutter Lip Ht (in)	N/A	N/A	Gutter X Slope (%)	N/A
N/A	Painted X Walk1?	No	N/A	Painted X Walk2?	No
	X Walk 1 Direction	To SE		X Walk 2 Direction	To NE
N/A	X Walk 1 Width (in)	N/A	N/A	X Walk 2 Width (in)	N/A
	X Walk 1 Slope (%)	2.5		X Walk 2 Slope (%)	5.9
	X Walk 1 X Slope (%)	5.3		X Walk 2 X Slope (%)	1.3

N/A	Ramp inside XWalk1?	N/A	N/A	Ramp inside XWalk2?	N/A
	Road Slope (%)	2.8	N/A	Clear Space?	N/A
	Road X Slope (%)	5.5	N/A	Clear Space to XWalk (in)	N/A
N/A	Any Obstructions?	N/A	N/A	Storm Grate/Utility Hazard?	N/A
	Obstruction Type			Storm Grate/Utility Type	
		N/A			N/A
		No		Surface Condition? (G/P)	Poor

Remove & Replace Curb Ramp With Two New Directional Ramps or Equivalent.
