Access Compliance Report

Public Rights-of-Way

(Curb Ramps)

Intersection ID: 8417	Main Street: POINSETT_ST	Cross Street: WAINWRIGHT_AV	Location: NW
ADA ID: 750C7A766DE9	Ramp Type: Para	Initial Pass/Fail: Fail	Overall Compliance: No
			Severity Score: 26.25

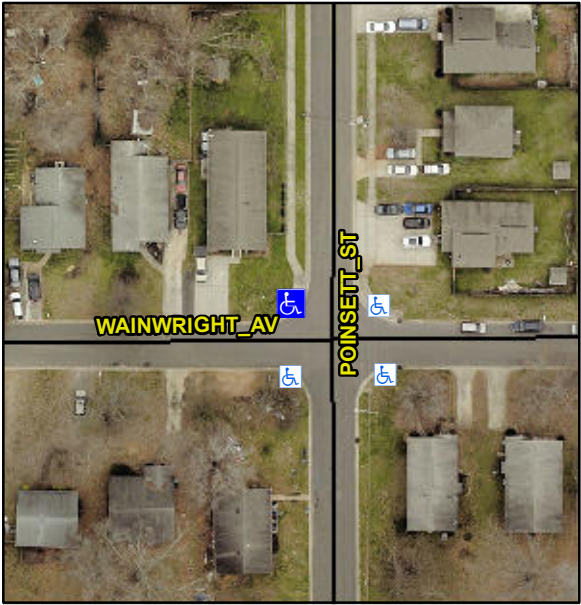
Surveyor Notes:		N/A	Ramp Length LT (in)	47.0
	LT RP < 5%		Yes	Ramp Width LT (in)	60.0

PROW/ADA:		Yes	Ramp Slope LT (%)	1.4
	R304.5.3, R304.3.2		No	Ramp XSlope LT (%)	2.8

Possible Solutions:		Compliance	Description	Data
	Remove & Replace Entire Ramp.		Compliance	Description	Data
