Access Compliance Report

Public Rights-of-Way

(Curb Ramps)

Intersection ID: N/A	Main Street: PROVIDENCE_RD	Cross Street: PROVIDENCE_CHURCH_LN	Location: SW
ADA ID: 7510454F60C4	Ramp Type: Perp	Initial Pass/Fail: Fail	Overall Compliance: No
Codes/Mitigation Info/Possible Solution		Field Measurements/Component Compliance

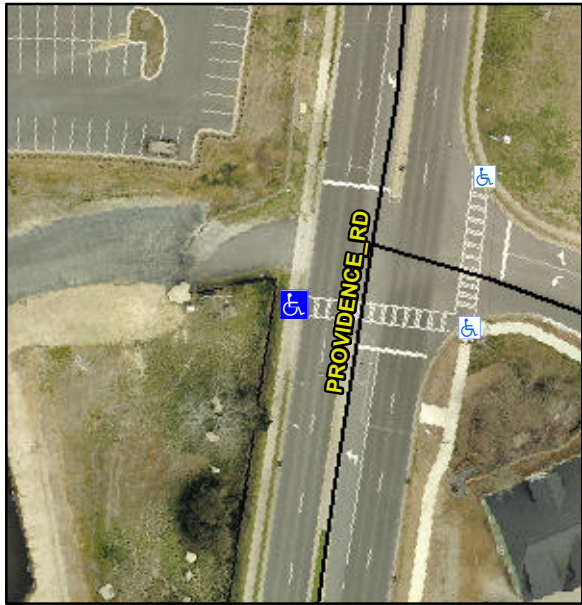
Not Found, R304.2.2

Compliance	Description	Data	Compliance	Description	Data
N/A	Ramp Length (in)	24.0	No	Ramp Slope (%)	14.9
Yes	Ramp Width (in)	110.0	Yes	Ramp XSlope (%)	2.5
N/A	Flare Type LT	N/A	N/A	Flare Type RT	N/A
N/A	Flare Slope LT (%)	N/A	N/A	Flare Slope RT (%)	N/A
N/A	Flare Traversable LT?	N/A	N/A	Flare Traversable RT?	N/A
N/A	Landing Length (in)	N/A	N/A	DWS Provided?	N/A
N/A	Landing Width (in)	N/A	N/A	DWS Contrast?	N/A
N/A	Landing Slope (%)	N/A	N/A	DWS Length (in)	N/A
N/A	Landing X Slope (%)	N/A	N/A	DWS Full Width?	N/A
N/A	Landing Curb? (Y/N)	N/A	N/A	DWS Offset (in)	N/A
N/A	Shared Landing?	N/A			
N/A	Gutter Ponding?	N/A	N/A	Gutter Slope (%)	N/A
N/A	Gutter Lip Ht (in)	N/A	N/A	Gutter X Slope (%)	N/A
N/A	Painted X Walk1?	Yes	N/A	Painted X Walk2?	N/A
	X Walk 1 Direction	To SE		X Walk 2 Direction	N/A
N/A	X Walk 1 Width (in)	111.0	N/A	X Walk 2 Width (in)	N/A
	X Walk 1 Slope (%)	1.6		X Walk 2 Slope (%)	N/A
	X Walk 1 X Slope (%)	3.9		X Walk 2 X Slope (%)	N/A

N/A	Ramp inside XWalk1?	Yes	N/A	Ramp inside XWalk2?	N/A
	Road Slope (%)	N/A	N/A	Clear Space?	N/A
	Road X Slope (%)	N/A	N/A	Clear Space to XWalk (in)	N/A
N/A	Any Obstructions?	N/A	N/A	Storm Grate/Utility Hazard?	N/A
	Obstruction Type			Storm Grate/Utility Type	
		N/A			N/A
			Yes	Surface Condition? (G/P)	Good

Remove & Replace Entire Ramp.
