# Access Compliance Report

## Public Rights-of-Way

### (Curb Ramps)

Intersection ID: 46788	Main Street: STOWE_ACRES_DR	Cross Street: ALMOND_HILLS_DR	Location: NE
ADA ID: 75181AE20D6A	Ramp Type: PerpDiag	Initial Pass/Fail: Fail	Overall Compliance: No
Severity Score: 22.5			
Codes/Mitigation Info/Possible Solution		Field Measurements/Component Compliance

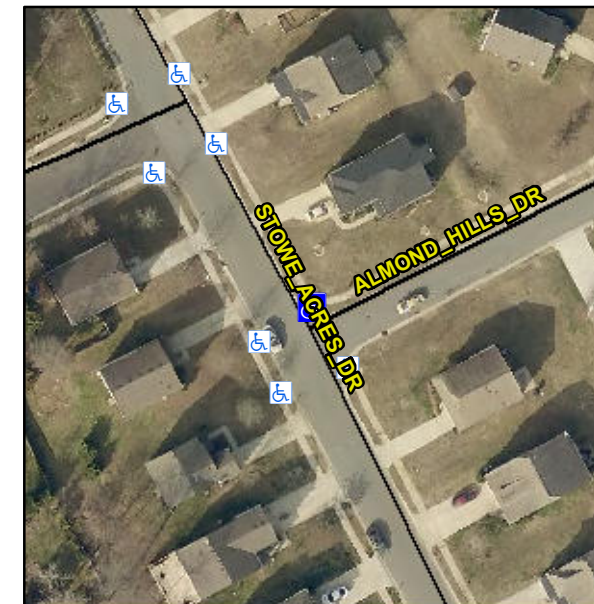
**Not Found, R304.5.1, R304.2.2, R304.5.3**

Compliance	Description	Data	Compliance	Description	Data
N/A	Ramp Length (in)	48.0	No	Ramp Slope (%)	9.0
No	Ramp Width (in)	37.0	No	Ramp XSlope (%)	2.2
N/A	Flare Type LT	N/A	N/A	Flare Type RT	N/A
N/A	Flare Slope LT (%)	N/A	N/A	Flare Slope RT (%)	N/A
N/A	Flare Traversable LT?	N/A	N/A	Flare Traversable RT?	N/A
N/A	Landing Length (in)	N/A	N/A	DWS Provided?	N/A
N/A	Landing Width (in)	N/A	N/A	DWS Contrast?	N/A
N/A	Landing Slope (%)	N/A	N/A	DWS Length (in)	N/A
N/A	Landing X Slope (%)	N/A	N/A	DWS Full Width?	N/A
N/A	Landing Curb? (Y/N)	N/A	N/A	DWS Offset (in)	N/A
N/A	Shared Landing?	N/A			
N/A	Gutter Ponding?	N/A	N/A	Gutter Slope (%)	N/A
N/A	Gutter Lip Ht (in)	N/A	N/A	Gutter X Slope (%)	N/A
N/A	Painted X Walk1?	No	N/A	Painted X Walk2?	No
	X Walk 1 Direction	To W		X Walk 2 Direction	To S
N/A	X Walk 1 Width (in)	N/A	N/A	X Walk 2 Width (in)	N/A
	X Walk 1 Slope (%)	2.8		X Walk 2 Slope (%)	1.0
	X Walk 1 X Slope (%)	1.0		X Walk 2 X Slope (%)	2.2

N/A	Ramp inside XWalk1?	N/A	N/A	Ramp inside XWalk2?	N/A
	Road Slope (%)	1.5	N/A	Clear Space?	N/A
	Road X Slope (%)	1.7	N/A	Clear Space to XWalk (in)	N/A
N/A	Any Obstructions?	N/A	N/A	Storm Grate/Utility Hazard?	N/A
	Obstruction Type			Storm Grate/Utility Type	
		N/A			N/A
			Yes	Surface Condition? (G/P)	Good

Possible Solutions:

**Remove & Replace Curb Ramp With Two New Directional Ramps or Equivalent.**

Total Cost: \$ 3200.00
