Access Compliance Report

Public Rights-of-Way

(Curb Ramps)

Intersection ID: 21408	Main Street: STARLITE_PL	Cross Street: WOODSTREAM_DR	Location: SE
ADA ID: 7525A51148F6	Ramp Type: PerpDiag	Initial Pass/Fail: Fail	Overall Compliance: No
		Severity Score: 12.5

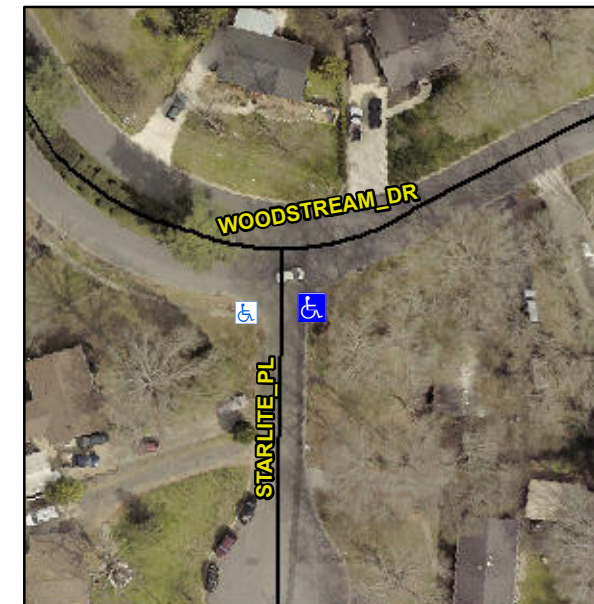
Not Found, R304.5.3

Compliance	Description	Data	Compliance	Description	Data
N/A	Ramp Length (in)	36.0	Yes	Ramp Slope (%)	5.2
Yes	Ramp Width (in)	56.0	No	Ramp XSlope (%)	6.1
N/A	Flare Type LT	N/A	N/A	Flare Type RT	N/A
N/A	Flare Slope LT (%)	N/A	N/A	Flare Slope RT (%)	N/A
N/A	Flare Traversable LT?	N/A	N/A	Flare Traversable RT?	N/A
N/A	Landing Length (in)	N/A	N/A	DWS Provided?	N/A
N/A	Landing Width (in)	N/A	N/A	DWS Contrast?	N/A
N/A	Landing Slope (%)	N/A	N/A	DWS Length (in)	N/A
N/A	Landing X Slope (%)	N/A	N/A	DWS Full Width?	N/A
N/A	Landing Curb? (Y/N)	N/A	N/A	DWS Offset (in)	N/A
N/A	Shared Landing?	N/A			
N/A	Gutter Ponding?	N/A	N/A	Gutter Slope (%)	N/A
N/A	Gutter Lip Ht (in)	N/A	N/A	Gutter X Slope (%)	N/A
N/A	Painted X Walk1?	No	N/A	Painted X Walk2?	No
	X Walk 1 Direction	To N		X Walk 2 Direction	To W
N/A	X Walk 1 Width (in)	N/A	N/A	X Walk 2 Width (in)	N/A
	X Walk 1 Slope (%)	1.2		X Walk 2 Slope (%)	5.1
	X Walk 1 X Slope (%)	6.3		X Walk 2 X Slope (%)	1.0

N/A	Ramp inside XWalk1?	N/A	N/A	Ramp inside XWalk2?	N/A
	Road Slope (%)	5.7	N/A	Clear Space?	N/A
	Road X Slope (%)	7.5	N/A	Clear Space to XWalk (in)	N/A
N/A	Any Obstructions?	N/A	N/A	Storm Grate/Utility Hazard?	N/A
	Obstruction Type			Storm Grate/Utility Type	
		N/A			N/A
			Yes	Surface Condition? (G/P)	Good

Remove & Replace Curb Ramp With Two New Directional Ramps or Equivalent.
