Access Compliance Report Public Rights-of-Way (Curb Ramps)

Intersection ID: 17688 Main Street: N SHARON AMITY RD **Cross Street: WHITBY LN** Location: **ADA ID: 7537E8FFE6B5** Ramp Type: PerpDiag Initial Pass/Fail: Fail **Overall Compliance: No Severity Score:** 10

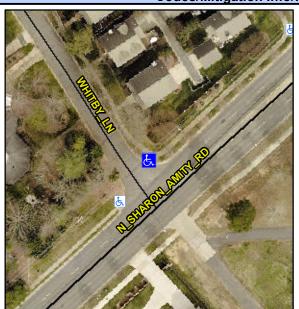
WHITBY LN Street 1 Name Stop Condition-Street 2 StopSign Street 2 Name N SHARON AMITY RD Stop Condition-Street 1

Compliance Description Da		Data	Compliance Description		Data
N/A	Ramp Length (in)	71.0	Yes	Ramp Slope (%)	5.5
No	Ramp Width (in)	47.5	No	Ramp XSlope (%)	4.2
N/A	Flare Type LT	N/A	N/A	Flare Type RT	N/A
N/A	Flare Slope LT (%)	N/A	N/A	Flare Slope RT (%)	N/A
N/A	Flare Traversable LT?	N/A	N/A	Flare Traversable RT?	N/A
N/A	Landing Length (in)	N/A	N/A	DWS Provided?	N/A
N/A	Landing Width (in)	N/A	N/A	DWS Contrast?	N/A
N/A	Landing Slope (%)	N/A	N/A	DWS Length (in)	N/A
N/A	Landing X Slope (%)	N/A	N/A	DWS Full Width?	N/A
N/A	Landing Curb? (Y/N)	N/A	N/A	DWS Offset (in)	N/A
N/A	Shared Landing?	N/A			
N/A	Gutter Ponding?	N/A	N/A	Gutter Slope (%)	N/A
N/A	Gutter Lip Ht (in)	N/A	N/A	Gutter X Slope (%)	N/A
N/A	Painted X Walk1?	No	N/A	Painted X Walk2?	No
	X Walk 1 Direction	To SW		X Walk 2 Direction	To SE
N/A	X Walk 1 Width (in)	N/A	N/A	X Walk 2 Width (in)	N/A
	X Walk 1 Slope (%)	5.4		X Walk 2 Slope (%)	0.4
	X Walk 1 X Slope (%)	0.5		X Walk 2 X Slope (%)	6.7

N/A	Ramp inside XWalk1?	N/A	N/A	Ramp inside XWalk2?	N/A
	Road Slope (%)	3.3	N/A	Clear Space?	N/A
	Road X Slope (%)	5.1	N/A	Clear Space to XWalk (in)	N/A
N/A	Any Obstructions?	N/A	N/A	Storm Grate/Utility Hazard?	N/A
	Obstruction Type			Storm Grate/Utility Type	
		N/A			N/A
			Yes	Surface Condition? (G/P)	Good

Possible Solutions: Remove & Replace Curb Ramp With **Two New Directional Ramps or** Equivalent. Surveyor Notes: N/A PROW/ADA: R304.5.1, R304.5.3
