# Access Compliance Report

## Public Rights-of-Way

### (Curb Ramps)

| Intersection ID: 17650 | Main Street: CRESTHILL_DR | Cross Street: IDLEWILD_RD | Location: SW |

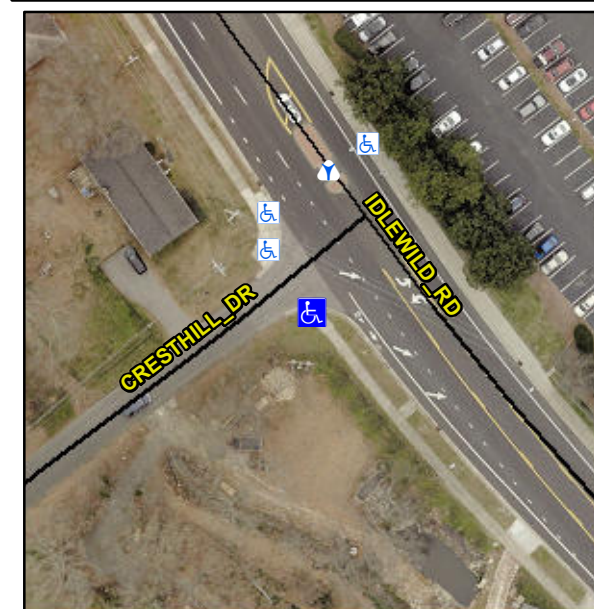
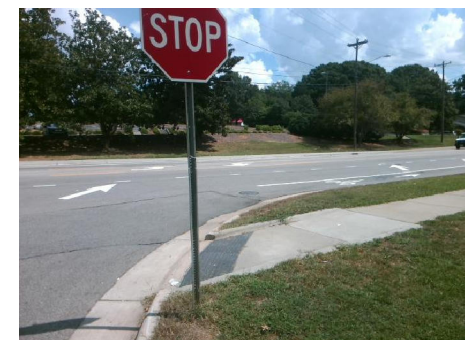
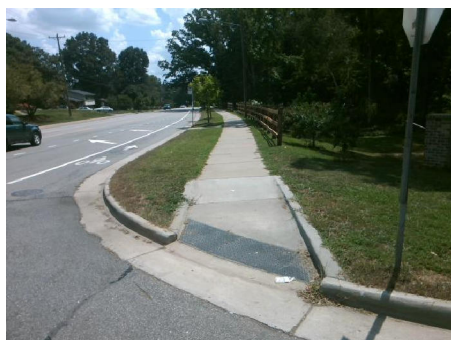
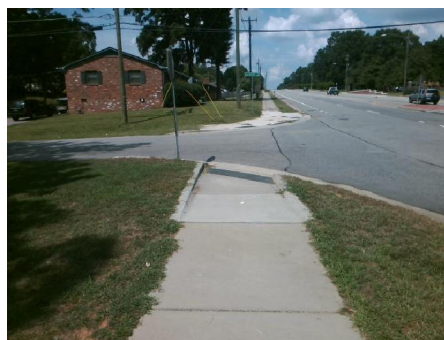
**Not Found, R304.5.3, R304.2.2-Perp, R304.3.2-Para, R304.5.4**

| Compliance | Description | Data | Compliance | Description | Data |
|---|---|---|---|---|---|
| Yes | Ramp Width (in) | 68.0 | No | BlendTrans XSlope (%) | 2.2 |
| No | Landing Slope (%) | 2.9 | Yes | DWS Length (in) | 24.0 |
| No | Landing X Slope (%) | 3.8 | Yes | DWS Full Width? | Yes |
| Yes | Gutter Ponding? | No | No | Gutter Slope (%) | 6.0 |

**Remove & Replace Curb Ramp With Two New Directional Ramps or Equivalent. Remove & Replace Gutter.**
