Access Compliance Report

Public Rights-of-Way

(Curb Ramps)

Intersection ID: 13620	Main Street: SHENANDOAH_AV	Cross Street: THE_PLAZA	Location: W
ADA ID: 7542D96804D2	Ramp Type: PerpDiag	Initial Pass/Fail: Fail	Overall Compliance: No
Severity Score: 21.25			
Codes/Mitigation Info/Possible Solution		Field Measurements/Component Compliance

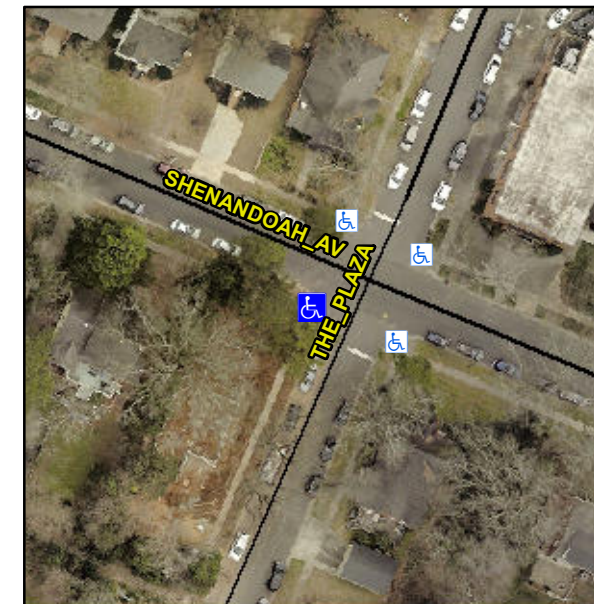
Not Found, R304.5.1, R304.2.2

Compliance	Description	Data	Compliance	Description	Data
N/A	Ramp Length (in)	54.0	No	Ramp Slope (%)	8.7
No	Ramp Width (in)	46.5	Yes	Ramp XSlope (%)	1.0
N/A	Flare Type LT	N/A	N/A	Flare Type RT	N/A
N/A	Flare Slope LT (%)	N/A	N/A	Flare Slope RT (%)	N/A
N/A	Flare Traversable LT?	N/A	N/A	Flare Traversable RT?	N/A
N/A	Landing Length (in)	N/A	N/A	DWS Provided?	N/A
N/A	Landing Width (in)	N/A	N/A	DWS Contrast?	N/A
N/A	Landing Slope (%)	N/A	N/A	DWS Length (in)	N/A
N/A	Landing X Slope (%)	N/A	N/A	DWS Full Width?	N/A
N/A	Landing Curb? (Y/N)	N/A	N/A	DWS Offset (in)	N/A
N/A	Shared Landing?	N/A			
N/A	Gutter Ponding?	N/A	N/A	Gutter Slope (%)	N/A
N/A	Gutter Lip Ht (in)	1.0	N/A	Gutter X Slope (%)	N/A
N/A	Painted X Walk1?	No	N/A	Painted X Walk2?	No
	X Walk 1 Direction	To SE		X Walk 2 Direction	To NE
N/A	X Walk 1 Width (in)	N/A	N/A	X Walk 2 Width (in)	N/A
	X Walk 1 Slope (%)	3.5		X Walk 2 Slope (%)	5.3
	X Walk 1 X Slope (%)	3.5		X Walk 2 X Slope (%)	4.4

N/A	Ramp inside XWalk1?	N/A	N/A	Ramp inside XWalk2?	N/A
	Road Slope (%)	3.9	N/A	Clear Space?	N/A
	Road X Slope (%)	5.3	N/A	Clear Space to XWalk (in)	N/A
N/A	Any Obstructions?	N/A	N/A	Storm Grate/Utility Hazard?	N/A
	Obstruction Type			Storm Grate/Utility Type	
		N/A			N/A
		Yes		Surface Condition? (G/P)	Good

Possible Solutions:

Remove & Replace Curb Ramp With Two New Directional Ramps or Equivalent.
