Access Compliance Report Public Rights-of-Way (Curb Ramps)

Intersection ID: 49140	Main Street: POPE_FARM_RD	Cross Street: CEMKEY_WAY_CT	Location: SW
ADA ID: 7544424D5F0D	Ramp Type: Perp	Initial Pass/Fail: Fail	Overall Compliance: No Severity Score: 21.25

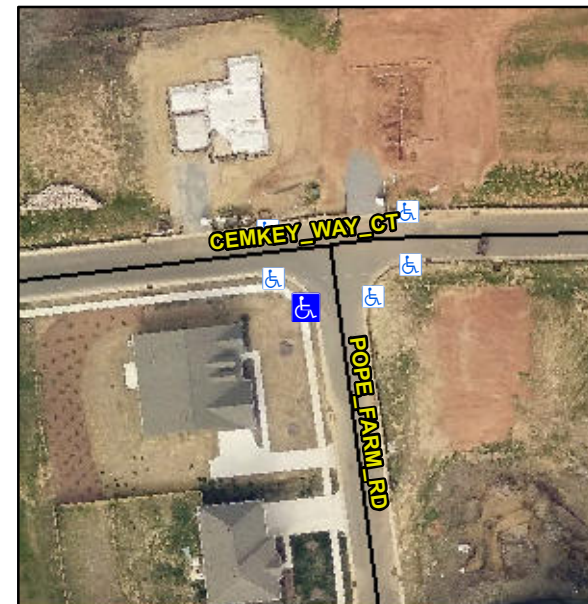
Not Found, R304.5.1, R304.5.3

Compliance	Description	Data	Compliance	Description	Data
N/A	Ramp Length (in)	45.5	Yes	Ramp Slope (%)	6.4
No	Ramp Width (in)	43.0	No	Ramp XSlope (%)	5.2
N/A	Flare Type LT	N/A	N/A	Flare Type RT	N/A
N/A	Flare Slope LT (%)	N/A	N/A	Flare Slope RT (%)	N/A
N/A	Flare Traversable LT?	N/A	N/A	Flare Traversable RT?	N/A
N/A	Landing Length (in)	N/A	N/A	DWS Provided?	N/A
N/A	Landing Width (in)	N/A	N/A	DWS Contrast?	N/A
N/A	Landing Slope (%)	N/A	N/A	DWS Length (in)	N/A
N/A	Landing X Slope (%)	N/A	N/A	DWS Full Width?	N/A
N/A	Landing Curb? (Y/N)	N/A	N/A	DWS Offset (in)	N/A
N/A	Shared Landing?	N/A			
N/A	Gutter Ponding?	N/A	N/A	Gutter Slope (%)	N/A
N/A	Gutter Lip Ht (in)	N/A	N/A	Gutter X Slope (%)	N/A
N/A	Painted X Walk1?	No	N/A	Painted X Walk2?	N/A
	X Walk 1 Direction	To E		X Walk 2 Direction	N/A
N/A	X Walk 1 Width (in)	N/A	N/A	X Walk 2 Width (in)	N/A
	X Walk 1 Slope (%)	3.3		X Walk 2 Slope (%)	N/A
	X Walk 1 X Slope (%)	5.8		X Walk 2 X Slope (%)	N/A

N/A	Ramp inside XWalk1?	N/A	N/A	Ramp inside XWalk2?	N/A
	Road Slope (%)	N/A	N/A	Clear Space?	N/A
	Road X Slope (%)	N/A	N/A	Clear Space to XWalk (in)	N/A
N/A	Any Obstructions?	N/A	N/A	Storm Grate/Utility Hazard?	N/A
	Obstruction Type			Storm Grate/Utility Type	
		N/A			N/A
			Yes	Surface Condition? (G/P)	Good

Possible Solutions:

Remove & Replace Entire Ramp.

Total Cost: \$ 1850.00
