## **Access Compliance Report Public Rights-of-Way** (Curb Ramps)

Intersection ID: 29738 Main Street: KING ARTHUR DR Cross Street: MERLIN\_MEADOWS\_CT Location: Ε **ADA ID: 754539E4DDEE** Ramp Type: PerpDiag Initial Pass/Fail: Fail **Overall Compliance: No Severity Score:** 10

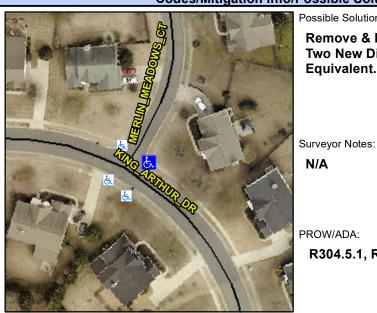
Field Measurements/Component Compliance						
Compliance Description		Data	Comp	liance	Description	Data
N/A	Ramp Length (in)	48.0	Yes	Ram	Slope (%)	7.3
No	Ramp Width (in)	36.0	No	<b>lo</b> Ramp XSlope (%)		2.9
N/A	Flare Type LT	N/A	N/A	<b>I/A</b> Flare Type RT		N/A
N/A	Flare Slope LT (%)	N/A	N/A	N/A Flare Slope RT (%)		N/A
N/A	Flare Traversable LT?	N/A	N/A	Flare Traversable RT?		N/A
N/A	Landing Length (in)	N/A	N/A	DWS	Provided?	N/A
N/A	Landing Width (in)	N/A	N/A	DWS	Contrast?	N/A
N/A	Landing Slope (%)	N/A	N/A	DWS	Length (in)	N/A
N/A	Landing X Slope (%)	N/A	N/A	DWS	Full Width?	N/A
N/A	Landing Curb? (Y/N)	N/A	N/A	DWS	Offset (in)	N/A
N/A	Shared Landing?	N/A				
N/A	Gutter Ponding?	N/A	N/A	Gutte	er Slope (%)	N/A
N/A	Gutter Lip Ht (in)	N/A	N/A	Gutte	er X Slope (%)	N/A
N/A	Painted X Walk1?	No	N/A	Paint	ed X Walk2?	No
	X Walk 1 Direction	To NW		X Wa	lk 2 Direction	To SW
N/A	X Walk 1 Width (in)	N/A	N/A	X Wa	lk 2 Width (in)	N/A

X Walk 1 Slope (%)	4.4		X Wa	lk 2 Slope (%)	4.4
	X Walk 1 X Slope (%)	1.4		X Wa	lk 2 X Slope (%)	4.3
N/A	Ramp inside XWalk1?	N/A	N/A	Ram	inside XWalk2?	N/A
	Road Slope (%)	1.2	N/A	Clear	Space?	N/A
	Road X Slope (%)	3.1	N/A	Clear	Space to XWalk (in)	N/A
N/A	Any Obstructions?	N/A	N/A	Storn	n Grate/Utility Hazard?	N/A
	Obstruction Type			Storn	n Grate/Utility Type	
		N/A				N/A
			Yes	Surfa	ce Condition? (G/P)	Good

Possible Solutions: **Remove & Replace Curb Ramp With Two New Directional Ramps or** Equivalent.

R304.5.1, R304.5.3
