# Access Compliance Report

## Public Rights-of-Way

### (Curb Ramps)

Intersection ID: 10759	Main Street: SPRATT_ST	Cross Street: OLIVER_ST	Location: NW
ADA ID: 754DB81F9963	Ramp Type: BlendTrans1	Initial Pass/Fail: Fail	Overall Compliance: No
			Severity Score: 16.25

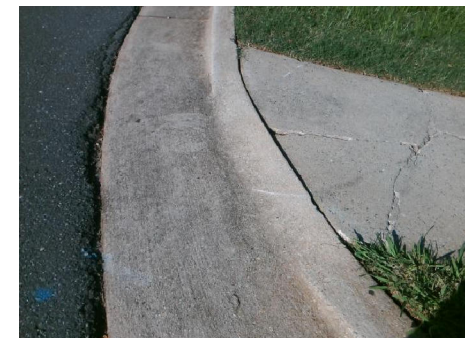
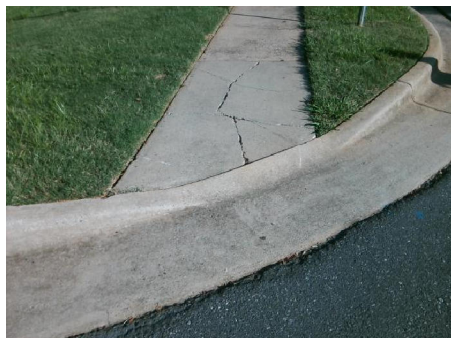
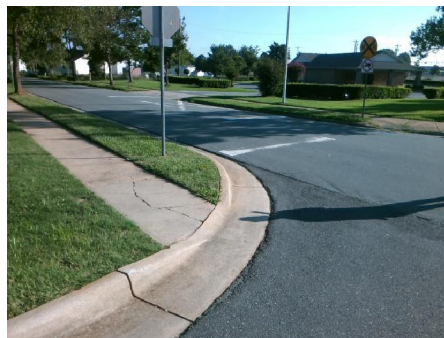
Compliance	Description	Data	Compliance	Description	Data
N/A	Ramp Length (in)	63.0	Yes	BlendTrans Slope (%)	0.3
Yes	Ramp Width (in)	48.5	No	BlendTrans XSlope (%)	2.7
N/A	Flare Type LT	N/A	N/A	Flare Type RT	N/A
N/A	Flare Slope LT (%)	N/A	N/A	Flare Slope RT (%)	N/A
N/A	Flare Traversable LT?	N/A	N/A	Flare Traversable RT?	N/A
N/A	Landing Length (in)	N/A	N/A	DWS Provided?	N/A
N/A	Landing Width (in)	N/A	N/A	DWS Contrast?	N/A
N/A	Landing Slope (%)	N/A	N/A	DWS Length (in)	N/A
N/A	Landing X Slope (%)	N/A	N/A	DWS Full Width?	N/A
N/A	Landing Curb? (Y/N)	N/A	N/A	DWS Offset (in)	N/A
N/A	Shared Landing?	N/A			
N/A	Gutter Ponding?	N/A	N/A	Gutter Slope (%)	N/A
N/A	Gutter Lip Ht (in)	N/A	N/A	Gutter X Slope (%)	N/A
N/A	Painted X Walk1?	No	N/A	Painted X Walk2?	N/A
	X Walk 1 Direction	To S		X Walk 2 Direction	N/A
	X Walk 1 Width (in)	N/A		X Walk 2 Width (in)	N/A
	X Walk 1 Slope (%)	0.3		X Walk 2 Slope (%)	N/A
	X Walk 1 X Slope (%)	4.5		X Walk 2 X Slope (%)	N/A

N/A	Ramp inside XWalk1?	N/A	N/A	Ramp inside XWalk2?	N/A
	Road Slope (%)	4.5		Clear Space?	N/A
	Road X Slope (%)	0.3	N/A	Clear Space to XWalk (in)	N/A
N/A	Any Obstructions?	N/A	N/A	Storm Grate/Utility Hazard?	N/A
	Obstruction Type			Storm Grate/Utility Type	
		N/A			N/A
		No	No	Surface Condition? (G/P)	Poor
		No	No	Curb Slope (%)	29.1

**Remove & Replace Curb Ramp With Two New Directional Ramps or Equivalent.**

**Not Found, R304.5.3, R302.7**
