Access Compliance Report

Public Rights-of-Way

(Curb Ramps)

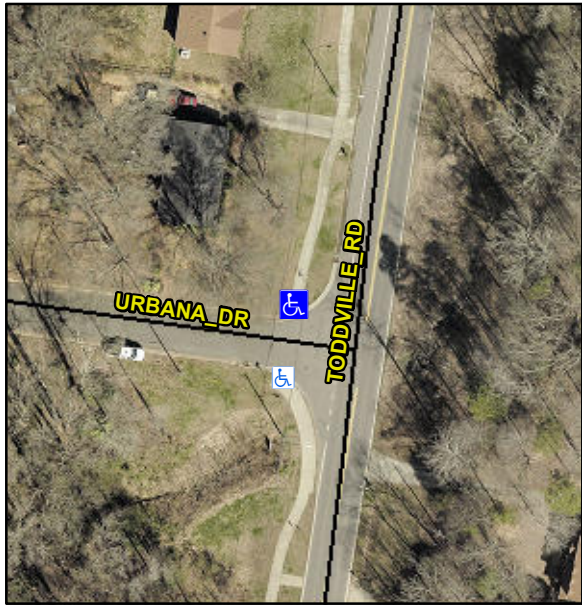
Intersection ID: 8828		Main Street: TODDVILLE_RD		Cross Street: URBANA_DR		Location:		N									
ADA ID: 755932738940		Ramp Type: Directional1		Initial Pass/Fail: Fail		Overall Compliance: No		Severity Score: 12.5									
Codes/Mitigation Info/Possible Solution				Field Measurements/Component Compliance													
<div>

</div> <div>Possible Solutions:</div> <div>Remove & Replace Entire Ramp.</div> <div>Surveyor Notes:</div> <div>N/A</div> <div>PROW/ADA:</div> <div>R304.2.2</div> <div>Street 1 Name</div> <div>URBANA DR</div> <div>Stop Condition-Street 1</div> <div>StopSign</div> <div>Street 2 Name</div> <div>N/A</div> <div>Stop Condition-Street 2</div> <div>N/A</div> <div>Total Cost:</div> <div>\$</div> <div>1600.00</div>				Compliance		Description		Data		Compliance		Description		Data			
				N/A		Ramp Length (in)		101.0		N/A		Grade Break?		N/A			
				Yes		Ramp Width (in)		71.0		N/A		Grade Break Slope (%)		0.0

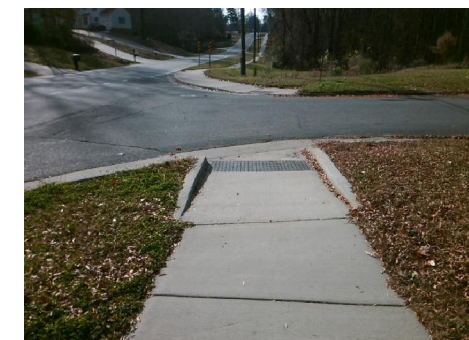
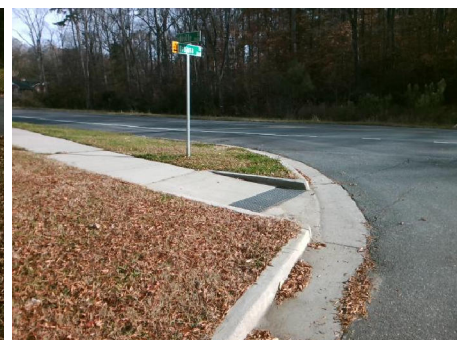
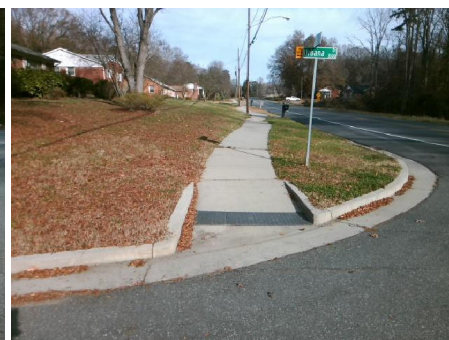
No		Ramp Slope (%)		9.1		N/A		Grade Break XSlope (%)		0.0			
				Yes		Ramp XSlope (%)		1.0									
				N/A		Flare Type LT		N/A		N/A		Flare Type RT		N/A			
				N/A		Flare Slope LT (%)		N/A		N/A		Flare Slope RT (%)		0.0			
				N/A		Flare Traversable LT?		N/A		N/A		Flare Traversable RT?		N/A			
				N/A		Landing Length (in)		0.0		N/A		DWS Provided?		N/A			
				N/A		Landing Width (in)		0.0		N/A		DWS Contrast?		N/A			
				N/A		Landing Slope (%)		0.0		N/A		DWS Length (in)		N/A			
				N/A		Landing X Slope (%)		0.0		N/A		DWS Full Width?		N/A			
				N/A		Landing Curb? (Y/N)		N/A		N/A		DWS Offset LT (in)		N/A			
				N/A		Shared Landing?		N/A		N/A		DWS Offset RT (in)		N/A			
				N/A		Gutter Ponding?		0.0		N/A		Gutter Slope (%)		N/A			
				N/A		Gutter Lip Ht (in)		0.0		N/A		Gutter X Slope (%)		N/A			
				N/A		Painted X Walk1?		No				Road Slope (%)		2.1			
						X Walk 1 Direction		To S				Road X Slope (%)		0.8

X Walk 1 Width (in)		N/A				Clear Space?		N/A			
						X Walk 1 Slope (%)		2.1		N/A		Clear Space to XWalk (in)		N/A			
						X Walk 1 X Slope (%)		0.8		N/A		Storm Grate/Utility Hazard?		N/A			
				N/A		Ramp inside XWalk1?		N/A				Storm Grate/Utility Type					
				N/A		Any Obstructions?		N/A						N/A			
						Obstruction Type				Yes		Surface Condition? (G/P)		Good			
										N/A		N/A		Curb Slope (%)		1.0
