Access Compliance Report

Public Rights-of-Way

(Curb Ramps)

Intersection ID: 21739	Main Street: IMPERIAL_CT	Cross Street: ENGLAND_ST	Location: SE
ADA ID: 755A41555A31	Ramp Type: BlendTrans2	Initial Pass/Fail: Fail	Overall Compliance: No
Severity Score: 21.25			
Codes/Mitigation Info/Possible Solution		Field Measurements/Component Compliance

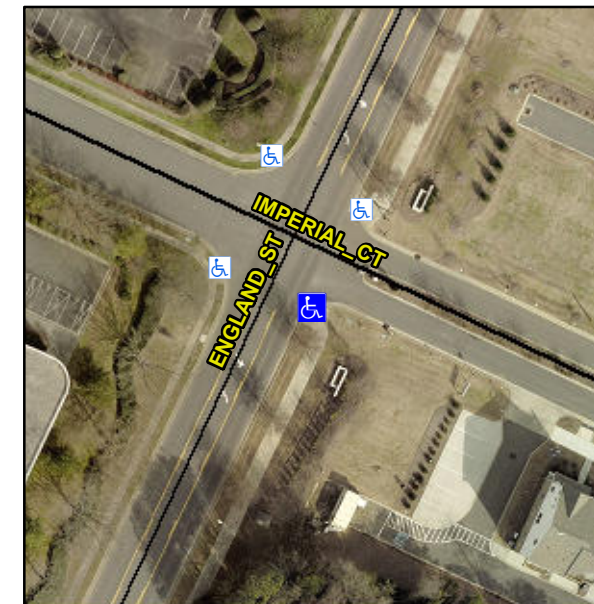
Not Found, R304.5.1, R304.5.3

Compliance	Description	Data	Compliance	Description	Data
N/A	Ramp Length (in)	162.0	Yes	BlendTrans Slope (%)	3.7
No	Ramp Width (in)	44.0	No	BlendTrans XSlope (%)	5.2
N/A	Flare Type LT	N/A	N/A	Flare Type RT	N/A
N/A	Flare Slope LT (%)	N/A	N/A	Flare Slope RT (%)	N/A
N/A	Flare Traversable LT?	N/A	N/A	Flare Traversable RT?	N/A
N/A	Landing Length (in)	N/A	N/A	DWS Provided?	N/A
N/A	Landing Width (in)	N/A	N/A	DWS Contrast?	N/A
N/A	Landing Slope (%)	N/A	N/A	DWS Length (in)	N/A
N/A	Landing X Slope (%)	N/A	N/A	DWS Full Width?	N/A
N/A	Landing Curb? (Y/N)	N/A	N/A	DWS Offset (in)	N/A
N/A	Shared Landing?	N/A			
N/A	Gutter Ponding?	N/A	N/A	Gutter Slope (%)	N/A
N/A	Gutter Lip Ht (in)	1.5	N/A	Gutter X Slope (%)	N/A
N/A	Painted X Walk1?	No	N/A	Painted X Walk2?	No
	X Walk 1 Direction	To NE		X Walk 2 Direction	To NW
	X Walk 1 Width (in)	N/A		X Walk 2 Width (in)	N/A
	X Walk 1 Slope (%)	7.4		X Walk 2 Slope (%)	4.0
	X Walk 1 X Slope (%)	8.4		X Walk 2 X Slope (%)	2.6

N/A	Ramp inside XWalk1?	N/A	N/A	Ramp inside XWalk2?	N/A
	Road Slope (%)	5.0		Clear Space?	N/A
	Road X Slope (%)	1.5	N/A	Clear Space to XWalk (in)	N/A
N/A	Any Obstructions?	N/A	N/A	Storm Grate/Utility Hazard?	N/A
	Obstruction Type			Storm Grate/Utility Type	
		N/A			N/A
			Yes	Surface Condition? (G/P)	Good
			No	Curb Slope (%)	13.4

Possible Solutions:

Remove & Replace Curb Ramp With Two New Directional Ramps or Equivalent.
