Access Compliance Report

Public Rights-of-Way

(Curb Ramps)

Intersection ID: 49505	Main Street: ADEL_LN	Cross Street: OSCEOLA_LN	Location: NE
ADA ID: 755BD548A066	Ramp Type: PerpDiag	Initial Pass/Fail: Fail	Overall Compliance: No
Severity Score: 13.75			
Codes/Mitigation Info/Possible Solution		Field Measurements/Component Compliance

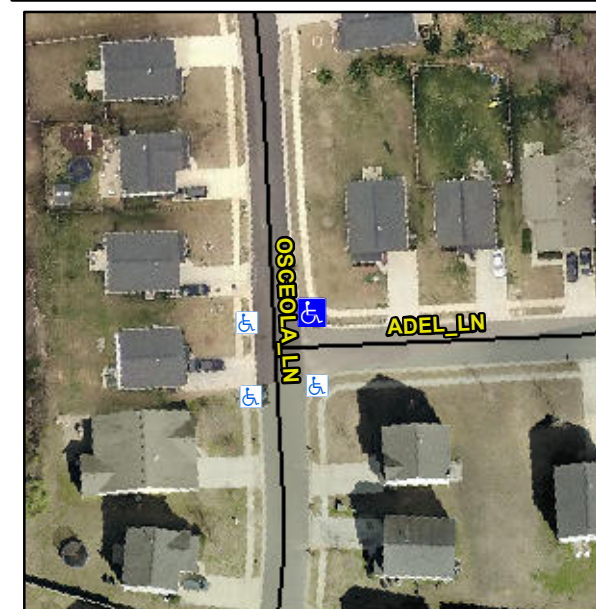
Not Found, R304.2.2, R304.5.3

Compliance	Description	Data	Compliance	Description	Data
N/A	Ramp Length (in)	48.0	No	Ramp Slope (%)	9.8
Yes	Ramp Width (in)	48.0	No	Ramp XSlope (%)	5.0
N/A	Flare Type LT	N/A	N/A	Flare Type RT	N/A
N/A	Flare Slope LT (%)	N/A	N/A	Flare Slope RT (%)	N/A
N/A	Flare Traversable LT?	N/A	N/A	Flare Traversable RT?	N/A
N/A	Landing Length (in)	N/A	N/A	DWS Provided?	N/A
N/A	Landing Width (in)	N/A	N/A	DWS Contrast?	N/A
N/A	Landing Slope (%)	N/A	N/A	DWS Length (in)	N/A
N/A	Landing X Slope (%)	N/A	N/A	DWS Full Width?	N/A
N/A	Landing Curb? (Y/N)	N/A	N/A	DWS Offset (in)	N/A
N/A	Shared Landing?	N/A			
N/A	Gutter Ponding?	N/A	N/A	Gutter Slope (%)	N/A
N/A	Gutter Lip Ht (in)	N/A	N/A	Gutter X Slope (%)	N/A
N/A	Painted X Walk1?	No	N/A	Painted X Walk2?	No
	X Walk 1 Direction	To W		X Walk 2 Direction	To S
N/A	X Walk 1 Width (in)	N/A	N/A	X Walk 2 Width (in)	N/A
	X Walk 1 Slope (%)	1.9		X Walk 2 Slope (%)	2.4
	X Walk 1 X Slope (%)	1.7		X Walk 2 X Slope (%)	4.2

N/A	Ramp inside XWalk1?	N/A	N/A	Ramp inside XWalk2?	N/A
	Road Slope (%)	4.1	N/A	Clear Space?	N/A
	Road X Slope (%)	0.5	N/A	Clear Space to XWalk (in)	N/A
N/A	Any Obstructions?	N/A	N/A	Storm Grate/Utility Hazard?	N/A
	Obstruction Type			Storm Grate/Utility Type	
		N/A			N/A
		Yes		Surface Condition? (G/P)	Good

Possible Solutions:

Remove & Replace Curb Ramp With Two New Directional Ramps or Equivalent.
