Access Compliance Report

Public Rights-of-Way

(Curb Ramps)

Intersection ID: 11965	Main Street: S_CEDAR_ST	Cross Street: GREENLEAF_AV	Location: W
ADA ID: 755CEF17D07E	Ramp Type: PerpDiag	Initial Pass/Fail: Fail	Overall Compliance: No
Severity Score: 22.5			
Codes/Mitigation Info/Possible Solution		Field Measurements/Component Compliance

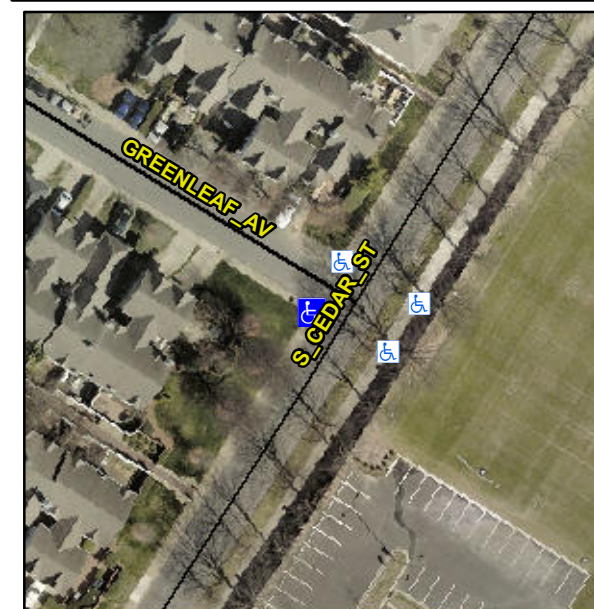
Not Found, R304.5.1, R304.2.2, R304.5.3

Compliance	Description	Data	Compliance	Description	Data
N/A	Ramp Length (in)	33.0	No	Ramp Slope (%)	9.1
No	Ramp Width (in)	40.0	No	Ramp XSlope (%)	4.5
N/A	Flare Type LT	N/A	N/A	Flare Type RT	N/A
N/A	Flare Slope LT (%)	N/A	N/A	Flare Slope RT (%)	N/A
N/A	Flare Traversable LT?	N/A	N/A	Flare Traversable RT?	N/A
N/A	Landing Length (in)	N/A	N/A	DWS Provided?	N/A
N/A	Landing Width (in)	N/A	N/A	DWS Contrast?	N/A
N/A	Landing Slope (%)	N/A	N/A	DWS Length (in)	N/A
N/A	Landing X Slope (%)	N/A	N/A	DWS Full Width?	N/A
N/A	Landing Curb? (Y/N)	N/A	N/A	DWS Offset (in)	N/A
N/A	Shared Landing?	N/A			
N/A	Gutter Ponding?	N/A	N/A	Gutter Slope (%)	N/A
N/A	Gutter Lip Ht (in)	N/A	N/A	Gutter X Slope (%)	N/A
N/A	Painted X Walk1?	No	N/A	Painted X Walk2?	No
	X Walk 1 Direction	To SE		X Walk 2 Direction	To NE
N/A	X Walk 1 Width (in)	N/A	N/A	X Walk 2 Width (in)	N/A
	X Walk 1 Slope (%)	5.9		X Walk 2 Slope (%)	2.0
	X Walk 1 X Slope (%)	1.2		X Walk 2 X Slope (%)	2.8

N/A	Ramp inside XWalk1?	N/A	N/A	Ramp inside XWalk2?	N/A
	Road Slope (%)	0.1	N/A	Clear Space?	N/A
	Road X Slope (%)	2.5	N/A	Clear Space to XWalk (in)	N/A
N/A	Any Obstructions?	N/A	N/A	Storm Grate/Utility Hazard?	N/A
	Obstruction Type			Storm Grate/Utility Type	
		N/A			N/A
			Yes	Surface Condition? (G/P)	Good

Possible Solutions:

Remove & Replace Curb Ramp With Two New Directional Ramps or Equivalent.
