Access Compliance Report

Public Rights-of-Way

(Curb Ramps)

Intersection ID: 44484	Main Street: FINN_HALL_AV	Cross Street: NEWFIELD_ST	Location:	N
ADA ID: 755EC2D7C9A7	Ramp Type: Perp	Initial Pass/Fail: Fail	Overall Compliance: No	Severity Score: 8.75
Codes/Mitigation Info/Possible Solution		Field Measurements/Component Compliance

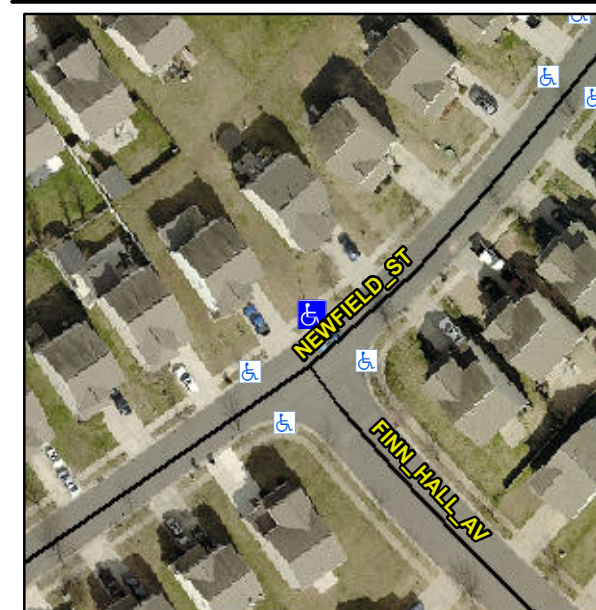
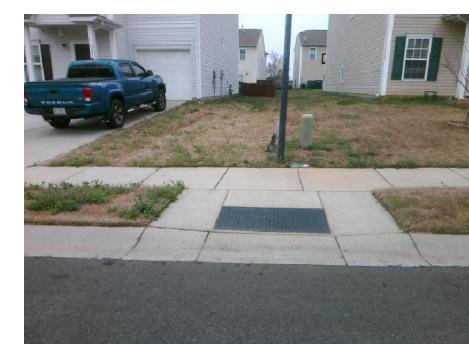
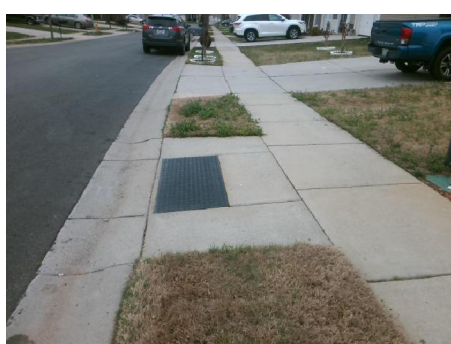
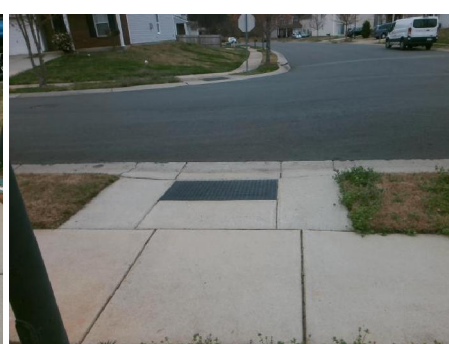
Not Found, R304.5.1

Compliance	Description	Data	Compliance	Description	Data
N/A	Ramp Length (in)	51.0	Yes	Ramp Slope (%)	6.5
No	Ramp Width (in)	47.5	Yes	Ramp XSlope (%)	0.6
N/A	Flare Type LT	N/A	N/A	Flare Type RT	N/A
N/A	Flare Slope LT (%)	N/A	N/A	Flare Slope RT (%)	N/A
N/A	Flare Traversable LT?	N/A	N/A	Flare Traversable RT?	N/A
N/A	Landing Length (in)	N/A	N/A	DWS Provided?	N/A
N/A	Landing Width (in)	N/A	N/A	DWS Contrast?	N/A
N/A	Landing Slope (%)	N/A	N/A	DWS Length (in)	N/A
N/A	Landing X Slope (%)	N/A	N/A	DWS Full Width?	N/A
N/A	Landing Curb? (Y/N)	N/A	N/A	DWS Offset (in)	N/A
N/A	Shared Landing?	N/A			
N/A	Gutter Ponding?	N/A	N/A	Gutter Slope (%)	N/A
N/A	Gutter Lip Ht (in)	N/A	N/A	Gutter X Slope (%)	N/A
N/A	Painted X Walk1?	No	N/A	Painted X Walk2?	N/A
	X Walk 1 Direction	To SE		X Walk 2 Direction	N/A
N/A	X Walk 1 Width (in)	N/A	N/A	X Walk 2 Width (in)	N/A
	X Walk 1 Slope (%)	2.5		X Walk 2 Slope (%)	N/A
	X Walk 1 X Slope (%)	1.9		X Walk 2 X Slope (%)	N/A

N/A	Ramp inside XWalk1?	N/A	N/A	Ramp inside XWalk2?	N/A
	Road Slope (%)	N/A	N/A	Clear Space?	N/A
	Road X Slope (%)	N/A	N/A	Clear Space to XWalk (in)	N/A
N/A	Any Obstructions?	N/A	N/A	Storm Grate/Utility Hazard?	N/A
	Obstruction Type			Storm Grate/Utility Type	
		N/A			N/A
			Yes	Surface Condition? (G/P)	Good

Remove & Replace Entire Ramp.

\$ 1850.00
