# Access Compliance Report

## Public Rights-of-Way

### (Curb Ramps)

Intersection ID: 32284	Main Street: LANDING_PLACE_LN	Cross Street: STEWARTS_BEND_LN	Location: SW
ADA ID: 756AAF36D2DF	Ramp Type: PerpDiag	Initial Pass/Fail: Fail	Overall Compliance: No
		Severity Score: 10

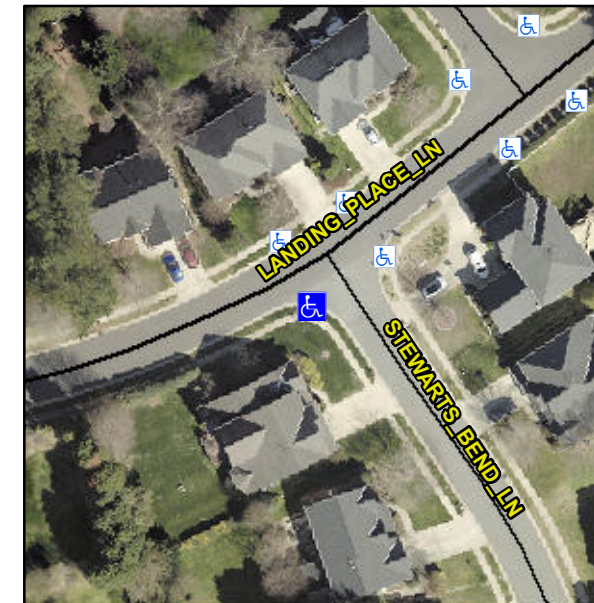
**Not Found, R304.5.1, R304.5.3**

Compliance	Description	Data	Compliance	Description	Data
N/A	Ramp Length (in)	49.0	Yes	Ramp Slope (%)	7.8
No	Ramp Width (in)	41.0	No	Ramp XSlope (%)	2.6
N/A	Flare Type LT	N/A	N/A	Flare Type RT	N/A
N/A	Flare Slope LT (%)	N/A	N/A	Flare Slope RT (%)	N/A
N/A	Flare Traversable LT?	N/A	N/A	Flare Traversable RT?	N/A
N/A	Landing Length (in)	N/A	N/A	DWS Provided?	N/A
N/A	Landing Width (in)	N/A	N/A	DWS Contrast?	N/A
N/A	Landing Slope (%)	N/A	N/A	DWS Length (in)	N/A
N/A	Landing X Slope (%)	N/A	N/A	DWS Full Width?	N/A
N/A	Landing Curb? (Y/N)	N/A	N/A	DWS Offset (in)	N/A
N/A	Shared Landing?	N/A			
N/A	Gutter Ponding?	N/A	N/A	Gutter Slope (%)	N/A
N/A	Gutter Lip Ht (in)	N/A	N/A	Gutter X Slope (%)	N/A
N/A	Painted X Walk1?	No	N/A	Painted X Walk2?	No
	X Walk 1 Direction	To NE		X Walk 2 Direction	To N
N/A	X Walk 1 Width (in)	N/A	N/A	X Walk 2 Width (in)	N/A
	X Walk 1 Slope (%)	3.0		X Walk 2 Slope (%)	4.9
	X Walk 1 X Slope (%)	4.7		X Walk 2 X Slope (%)	1.1

N/A	Ramp inside XWalk1?	N/A	N/A	Ramp inside XWalk2?	N/A
	Road Slope (%)	2.1	N/A	Clear Space?	N/A
	Road X Slope (%)	3.6	N/A	Clear Space to XWalk (in)	N/A
N/A	Any Obstructions?	N/A	N/A	Storm Grate/Utility Hazard?	N/A
	Obstruction Type			Storm Grate/Utility Type	
		N/A			N/A
			Yes	Surface Condition? (G/P)	Good

**Remove & Replace Curb Ramp With Two New Directional Ramps or Equivalent.**
