Access Compliance Report

Public Rights-of-Way

(Curb Ramps)

Intersection ID: 44172	Main Street: SOUTHBROOK_DR	Cross Street: BELLEGARDE_DR	Location: NW
ADA ID: 756C3596D22F	Ramp Type: PerpDiag	Initial Pass/Fail: Fail	Overall Compliance: No
Severity Score: 22.5			
Codes/Mitigation Info/Possible Solution		Field Measurements/Component Compliance

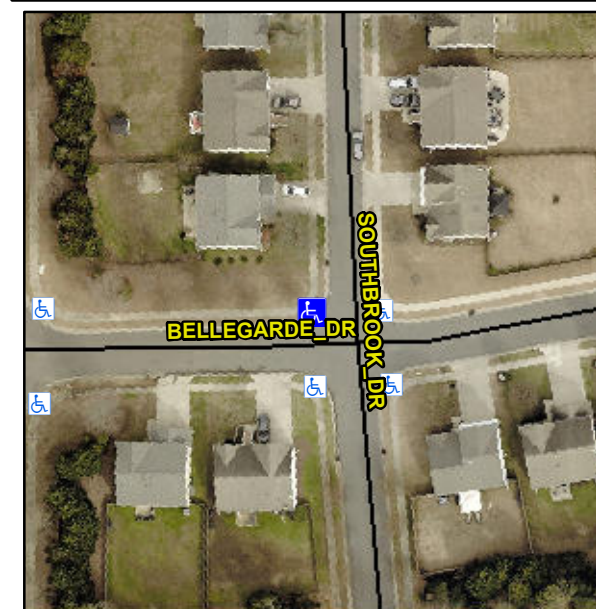
Not Found, R304.5.1, R304.2.2, R304.5.3

Compliance	Description	Data	Compliance	Description	Data
N/A	Ramp Length (in)	48.0	No	Ramp Slope (%)	10.3
No	Ramp Width (in)	37.0	No	Ramp XSlope (%)	3.1
N/A	Flare Type LT	N/A	N/A	Flare Type RT	N/A
N/A	Flare Slope LT (%)	N/A	N/A	Flare Slope RT (%)	N/A
N/A	Flare Traversable LT?	N/A	N/A	Flare Traversable RT?	N/A
N/A	Landing Length (in)	N/A	N/A	DWS Provided?	N/A
N/A	Landing Width (in)	N/A	N/A	DWS Contrast?	N/A
N/A	Landing Slope (%)	N/A	N/A	DWS Length (in)	N/A
N/A	Landing X Slope (%)	N/A	N/A	DWS Full Width?	N/A
N/A	Landing Curb? (Y/N)	N/A	N/A	DWS Offset (in)	N/A
N/A	Shared Landing?	N/A			
N/A	Gutter Ponding?	N/A	N/A	Gutter Slope (%)	N/A
N/A	Gutter Lip Ht (in)	N/A	N/A	Gutter X Slope (%)	N/A
N/A	Painted X Walk1?	No	N/A	Painted X Walk2?	No
	X Walk 1 Direction	To S		X Walk 2 Direction	To E
N/A	X Walk 1 Width (in)	N/A	N/A	X Walk 2 Width (in)	N/A
	X Walk 1 Slope (%)	1.0		X Walk 2 Slope (%)	2.0
	X Walk 1 X Slope (%)	2.1		X Walk 2 X Slope (%)	0.1

N/A	Ramp inside XWalk1?	N/A	N/A	Ramp inside XWalk2?	N/A
	Road Slope (%)	2.1	N/A	Clear Space?	N/A
	Road X Slope (%)	0.4	N/A	Clear Space to XWalk (in)	N/A
N/A	Any Obstructions?	N/A	N/A	Storm Grate/Utility Hazard?	N/A
	Obstruction Type			Storm Grate/Utility Type	
		N/A			N/A
		Yes		Surface Condition? (G/P)	Good

Remove & Replace Curb Ramp With Two New Directional Ramps or Equivalent.
