Access Compliance Report

Public Rights-of-Way

(Curb Ramps)

Intersection ID: 10029589	Main Street: KILSYTH_ST	Cross Street: N/A	Location: SW
ADA ID: 756F2BFF046F	Ramp Type: Perp	Initial Pass/Fail: Fail	Overall Compliance: No
Severity Score: 13.75			
Codes/Mitigation Info/Possible Solution		Field Measurements/Component Compliance

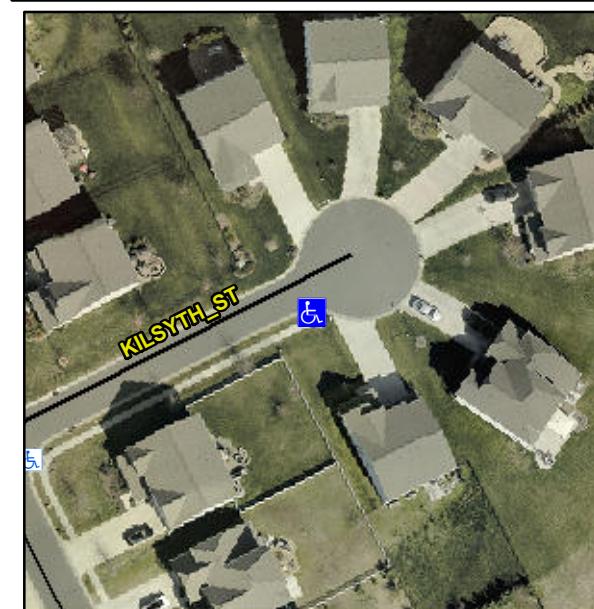
Compliance	Description	Data	Compliance	Description	Data
N/A	Ramp Length (in)	49.0	No	Ramp Slope (%)	9.3
Yes	Ramp Width (in)	48.0	No	Ramp XSlope (%)	2.1
N/A	Flare Type LT	N/A	N/A	Flare Type RT	N/A
N/A	Flare Slope LT (%)	N/A	N/A	Flare Slope RT (%)	N/A
N/A	Flare Traversable LT?	N/A	N/A	Flare Traversable RT?	N/A
N/A	Landing Length (in)	N/A	N/A	DWS Provided?	N/A
N/A	Landing Width (in)	N/A	N/A	DWS Contrast?	N/A
N/A	Landing Slope (%)	N/A	N/A	DWS Length (in)	N/A
N/A	Landing X Slope (%)	N/A	N/A	DWS Full Width?	N/A
N/A	Landing Curb? (Y/N)	N/A	N/A	DWS Offset (in)	N/A
N/A	Shared Landing?	N/A			
N/A	Gutter Ponding?	N/A	N/A	Gutter Slope (%)	N/A
N/A	Gutter Lip Ht (in)	N/A	N/A	Gutter X Slope (%)	N/A
N/A	Painted X Walk1?	No	N/A	Painted X Walk2?	N/A
	X Walk 1 Direction	To NW		X Walk 2 Direction	N/A
N/A	X Walk 1 Width (in)	N/A	N/A	X Walk 2 Width (in)	N/A
	X Walk 1 Slope (%)	4.0		X Walk 2 Slope (%)	N/A
	X Walk 1 X Slope (%)	0.8		X Walk 2 X Slope (%)	N/A

N/A	Ramp inside XWalk1?	N/A	N/A	Ramp inside XWalk2?	N/A
	Road Slope (%)	N/A	N/A	Clear Space?	N/A
	Road X Slope (%)	N/A	N/A	Clear Space to XWalk (in)	N/A
N/A	Any Obstructions?	N/A	N/A	Storm Grate/Utility Hazard?	N/A
	Obstruction Type			Storm Grate/Utility Type	
		N/A			N/A
			Yes	Surface Condition? (G/P)	Good

Possible Solutions:

Remove & Replace Entire Ramp.

R304.2.2, R304.5.3
