Access Compliance Report

Public Rights-of-Way

(Curb Ramps)

| Intersection ID: 49102 | Main Street: PROSPERITY_CROSSING_DR | Cross Street: BENFIELD_RD | Location: E |

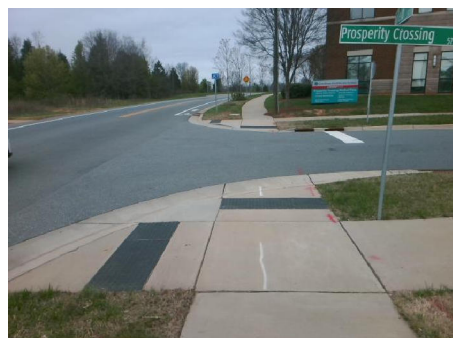
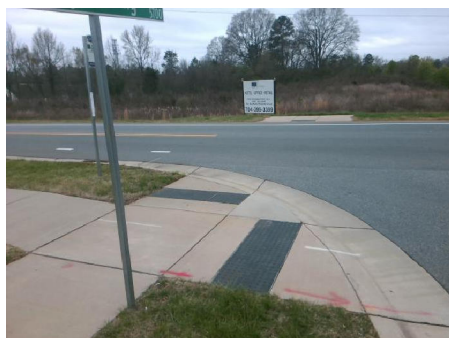
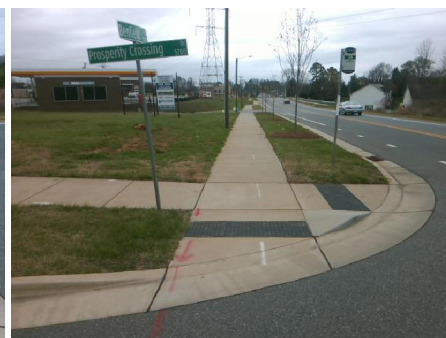
| ADA ID: 7575CDCC0032 | Ramp Type: Directional1 | Initial Pass/Fail: Pass | Overall Compliance: No |
| Severity Score: 5 | | | |

| Compliance | Description | Data | Compliance | Description | Data |
|---|---|---|---|---|---|
| Yes | Gutter Ponding? | No | No | Gutter Slope (%) | 6.2 |

Possible Solutions:

Remove & Replace Gutter.

PROW/ADA:

R304.5.4

Total Cost: \$ **750.00**
