# Access Compliance Report

## Public Rights-of-Way

### (Curb Ramps)

| Intersection ID: 10033270 | Main Street: OAKDALE_GREEN_DR | Cross Street: N/A | Location: SE |

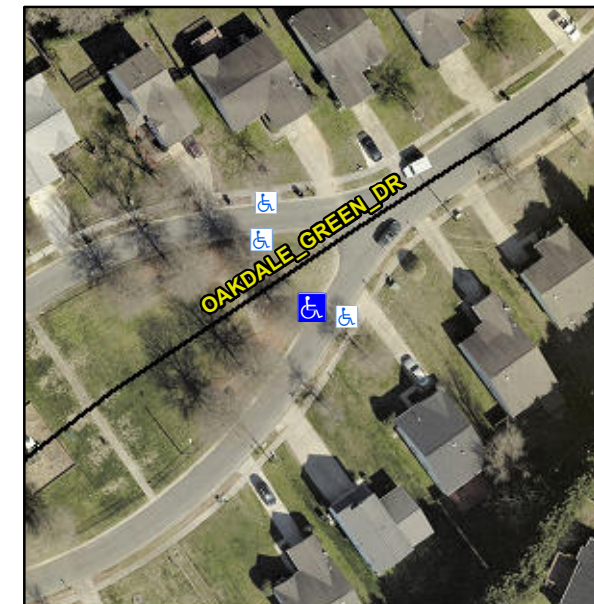
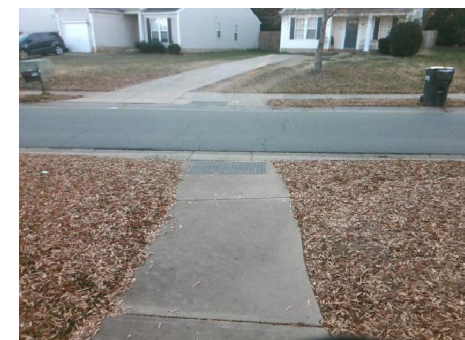
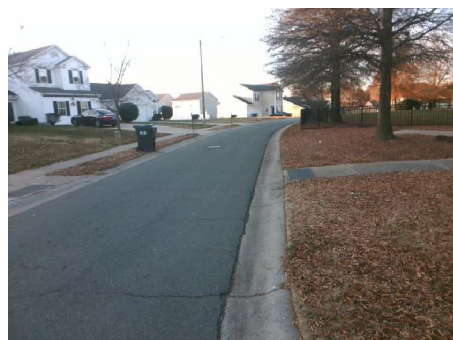
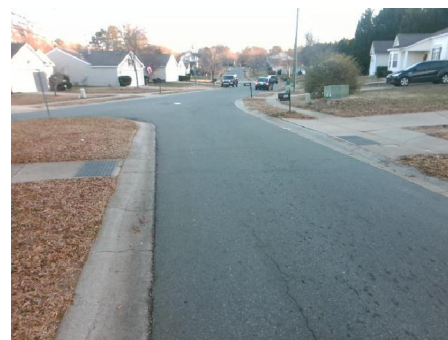
| ADA ID: 7579E4FF7F00 | Ramp Type: BlendTrans1 | Initial Pass/Fail: Pass | Overall Compliance: No |
| | | Severity Score: 0.25 | |

**Not Found, R304.5.3, R305.2**

| Compliance | Description | Data | Compliance | Description | Data |
|---|---|---|---|---|---|
| Yes | Ramp Width (in) | 61.0 | No | BlendTrans XSlope (%) | 2.2 |
| No | Landing X Slope (%) | 2.7 | Yes | DWS Full Width? | Yes |
| N/A | Landing Curb? (Y/N) | No | No | DWS Offset (in) | 4.5 |
| | | | No | Curb Slope (%) | 16.6 |

**Remove & Replace Curb Ramp With Two New Directional Ramps or Equivalent.**

Total Cost: \$ 3200.00
