Access Compliance Report

Public Rights-of-Way

(Curb Ramps)

Intersection ID: 3302	Main Street: STATESVILLE_RD	Cross Street: METROMONT_PY	Location: SE
ADA ID: 758022DF4F45	Ramp Type: Perp	Initial Pass/Fail: Fail	Overall Compliance: No
Severity Score: 28.75			
Codes/Mitigation Info/Possible Solution		Field Measurements/Component Compliance

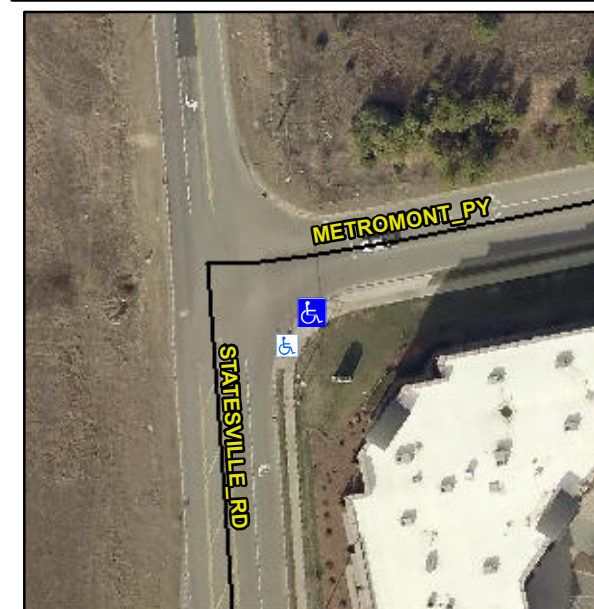
Compliance	Description	Data	Compliance	Description	Data
N/A	Ramp Length (in)	46.5	No	Ramp Slope (%)	10.8
Yes	Ramp Width (in)	48.0	No	Ramp XSlope (%)	2.5
N/A	Flare Type LT	N/A	N/A	Flare Type RT	N/A
N/A	Flare Slope LT (%)	N/A	N/A	Flare Slope RT (%)	N/A
N/A	Flare Traversable LT?	N/A	N/A	Flare Traversable RT?	N/A
N/A	Landing Length (in)	N/A	N/A	DWS Provided?	N/A
N/A	Landing Width (in)	N/A	N/A	DWS Contrast?	N/A
N/A	Landing Slope (%)	N/A	N/A	DWS Length (in)	N/A
N/A	Landing X Slope (%)	N/A	N/A	DWS Full Width?	N/A
N/A	Landing Curb? (Y/N)	N/A	N/A	DWS Offset (in)	N/A
N/A	Shared Landing?	N/A			
N/A	Gutter Ponding?	N/A	N/A	Gutter Slope (%)	N/A
N/A	Gutter Lip Ht (in)	N/A	N/A	Gutter X Slope (%)	N/A
N/A	Painted X Walk1?	No	N/A	Painted X Walk2?	N/A
	X Walk 1 Direction	To N		X Walk 2 Direction	N/A
N/A	X Walk 1 Width (in)	N/A	N/A	X Walk 2 Width (in)	N/A
	X Walk 1 Slope (%)	5.3		X Walk 2 Slope (%)	N/A
	X Walk 1 X Slope (%)	2.9		X Walk 2 X Slope (%)	N/A

N/A	Ramp inside XWalk1?	N/A	N/A	Ramp inside XWalk2?	N/A
	Road Slope (%)	N/A	N/A	Clear Space?	N/A
	Road X Slope (%)	N/A	N/A	Clear Space to XWalk (in)	N/A
N/A	Any Obstructions?	N/A	N/A	Storm Grate/Utility Hazard?	N/A
	Obstruction Type			Storm Grate/Utility Type	
		N/A			N/A
		No		Surface Condition? (G/P)	Poor

Possible Solutions:

Remove & Replace Entire Ramp.

R304.2.2, R304.5.3, R302.7
