# Access Compliance Report

## Public Rights-of-Way

### (Curb Ramps)

Intersection ID: 20697	Main Street: EMERALD_MEADOW_LN	Cross Street: SILVER_COACH_LN	Location: W
ADA ID: 75874333AD33	Ramp Type: PerpDiag	Initial Pass/Fail: Fail	Overall Compliance: No
		Severity Score: 12.5

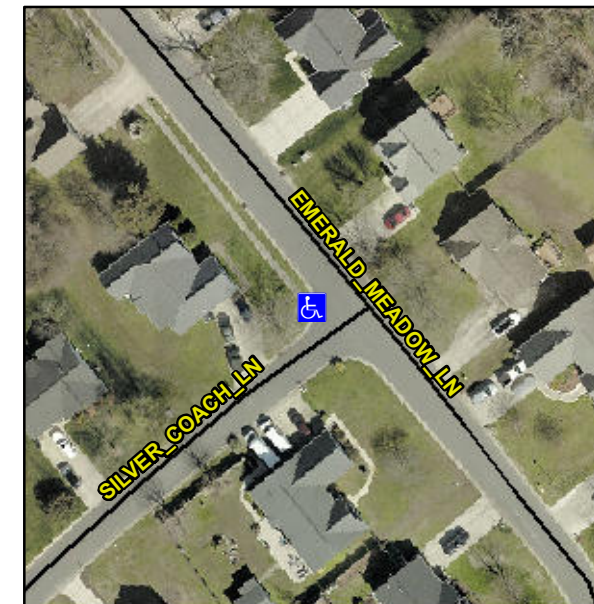
Compliance	Description	Data	Compliance	Description	Data
N/A	Ramp Length (in)	48.0	No	Ramp Slope (%)	8.7
Yes	Ramp Width (in)	48.0	Yes	Ramp XSlope (%)	1.5
N/A	Flare Type LT	N/A	N/A	Flare Type RT	N/A
N/A	Flare Slope LT (%)	N/A	N/A	Flare Slope RT (%)	N/A
N/A	Flare Traversable LT?	N/A	N/A	Flare Traversable RT?	N/A
N/A	Landing Length (in)	N/A	N/A	DWS Provided?	N/A
N/A	Landing Width (in)	N/A	N/A	DWS Contrast?	N/A
N/A	Landing Slope (%)	N/A	N/A	DWS Length (in)	N/A
N/A	Landing X Slope (%)	N/A	N/A	DWS Full Width?	N/A
N/A	Landing Curb? (Y/N)	N/A	N/A	DWS Offset (in)	N/A
N/A	Shared Landing?	N/A			
N/A	Gutter Ponding?	N/A	N/A	Gutter Slope (%)	N/A
N/A	Gutter Lip Ht (in)	N/A	N/A	Gutter X Slope (%)	N/A
N/A	Painted X Walk1?	No	N/A	Painted X Walk2?	No
	X Walk 1 Direction	To SE		X Walk 2 Direction	To NE
N/A	X Walk 1 Width (in)	N/A	N/A	X Walk 2 Width (in)	N/A
	X Walk 1 Slope (%)	0.8		X Walk 2 Slope (%)	0.2
	X Walk 1 X Slope (%)	0.4		X Walk 2 X Slope (%)	0.7

N/A	Ramp inside XWalk1?	N/A	N/A	Ramp inside XWalk2?	N/A
	Road Slope (%)	1.1	N/A	Clear Space?	N/A
	Road X Slope (%)	2.2	N/A	Clear Space to XWalk (in)	N/A
N/A	Any Obstructions?	N/A	N/A	Storm Grate/Utility Hazard?	N/A
	Obstruction Type			Storm Grate/Utility Type	
		N/A			N/A
			Yes	Surface Condition? (G/P)	Good

Possible Solutions:

**Remove & Replace Curb Ramp With Two New Directional Ramps or Equivalent.**

**R304.2.2**
