Access Compliance Report

Public Rights-of-Way

(Curb Ramps)

Intersection ID: 15229	Main Street: CHARLOTTE_DR	Cross Street: IDEAL_WY	Location: W
ADA ID: 75876E2A8B59	Ramp Type: Perp	Initial Pass/Fail: Fail	Overall Compliance: No
Severity Score: 13.75			
Codes/Mitigation Info/Possible Solution		Field Measurements/Component Compliance

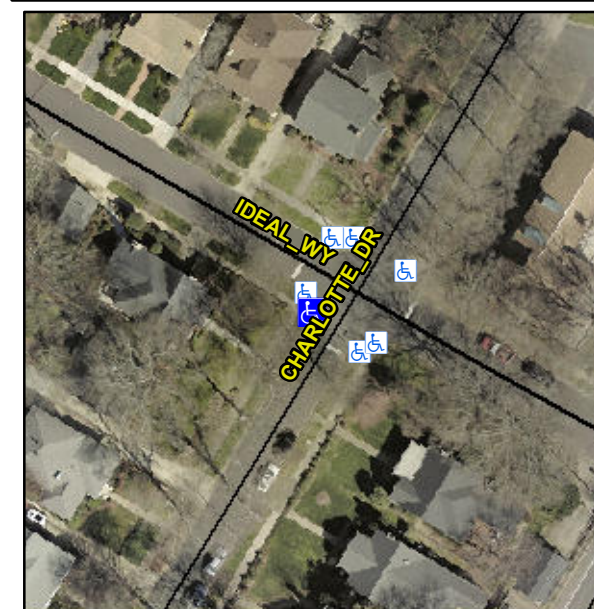
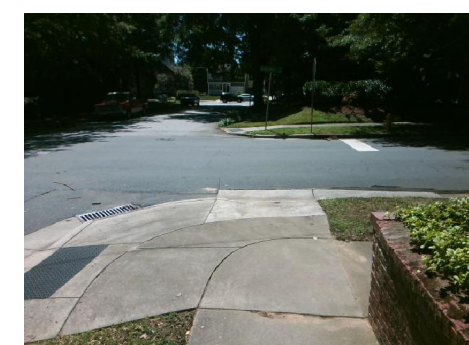
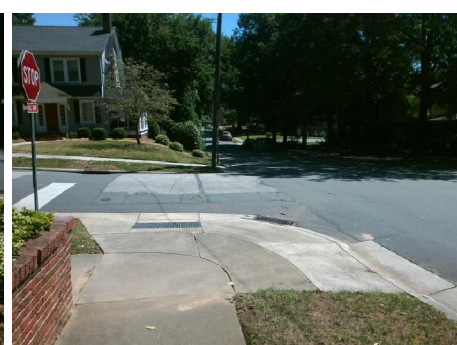
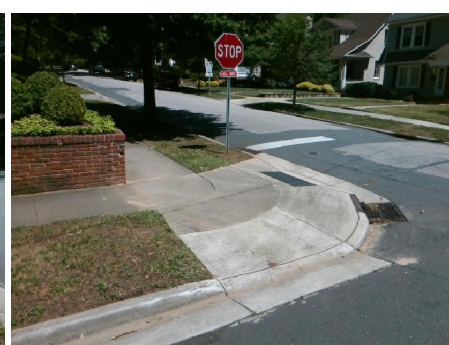
Not Found, R304.2.2, R304.5.3

Compliance	Description	Data	Compliance	Description	Data
N/A	Ramp Length (in)	77.0	No	Ramp Slope (%)	11.6
Yes	Ramp Width (in)	48.0	No	Ramp XSlope (%)	2.3
N/A	Flare Type LT	N/A	N/A	Flare Type RT	N/A
N/A	Flare Slope LT (%)	N/A	N/A	Flare Slope RT (%)	N/A
N/A	Flare Traversable LT?	N/A	N/A	Flare Traversable RT?	N/A
N/A	Landing Length (in)	N/A	N/A	DWS Provided?	N/A
N/A	Landing Width (in)	N/A	N/A	DWS Contrast?	N/A
N/A	Landing Slope (%)	N/A	N/A	DWS Length (in)	N/A
N/A	Landing X Slope (%)	N/A	N/A	DWS Full Width?	N/A
N/A	Landing Curb? (Y/N)	N/A	N/A	DWS Offset (in)	N/A
N/A	Shared Landing?	N/A			
N/A	Gutter Ponding?	N/A	N/A	Gutter Slope (%)	N/A
N/A	Gutter Lip Ht (in)	N/A	N/A	Gutter X Slope (%)	N/A
N/A	Painted X Walk1?	No	N/A	Painted X Walk2?	N/A
	X Walk 1 Direction	To SE		X Walk 2 Direction	N/A
N/A	X Walk 1 Width (in)	N/A	N/A	X Walk 2 Width (in)	N/A
	X Walk 1 Slope (%)	3.1		X Walk 2 Slope (%)	N/A
	X Walk 1 X Slope (%)	3.5		X Walk 2 X Slope (%)	N/A

N/A	Ramp inside XWalk1?	N/A	N/A	Ramp inside XWalk2?	N/A
	Road Slope (%)	N/A	N/A	Clear Space?	N/A
	Road X Slope (%)	N/A	N/A	Clear Space to XWalk (in)	N/A
N/A	Any Obstructions?	N/A	N/A	Storm Grate/Utility Hazard?	N/A
	Obstruction Type			Storm Grate/Utility Type	
		N/A			N/A
			Yes	Surface Condition? (G/P)	Good

Remove & Replace Entire Ramp.

Total Cost: \$ 1850.00
