Access Compliance Report

Public Rights-of-Way (Curb Ramps)

Intersection ID: N/A	Main Street: AGNEW_DR	Cross Street: PAMPLIN_CT	Location: NW
ADA ID: 75A4B2ABAB18	Ramp Type: Perp	Initial Pass/Fail: Fail	Overall Compliance: No
		Severity Score: 25

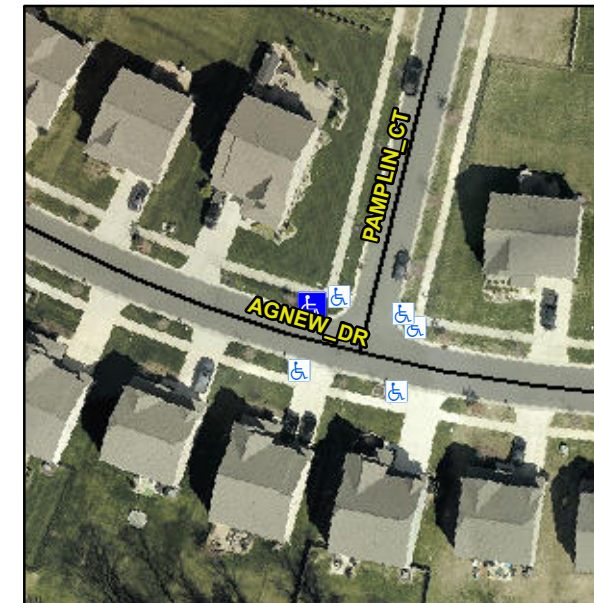
Compliance	Description	Data	Compliance	Description	Data
N/A	Ramp Length (in)	97.0	No	Ramp Slope (%)	13.2
Yes	Ramp Width (in)	48.0	Yes	Ramp XSlope (%)	1.0
N/A	Flare Type LT	N/A	N/A	Flare Type RT	N/A
N/A	Flare Slope LT (%)	N/A	N/A	Flare Slope RT (%)	N/A
N/A	Flare Traversable LT?	N/A	N/A	Flare Traversable RT?	N/A
N/A	Landing Length (in)	N/A	N/A	DWS Provided?	N/A
N/A	Landing Width (in)	N/A	N/A	DWS Contrast?	N/A
N/A	Landing Slope (%)	N/A	N/A	DWS Length (in)	N/A
N/A	Landing X Slope (%)	N/A	N/A	DWS Full Width?	N/A
N/A	Landing Curb? (Y/N)	N/A	N/A	DWS Offset (in)	N/A
N/A	Shared Landing?	N/A			
N/A	Gutter Ponding?	N/A	N/A	Gutter Slope (%)	N/A
N/A	Gutter Lip Ht (in)	N/A	N/A	Gutter X Slope (%)	N/A
N/A	Painted X Walk1?	No	N/A	Painted X Walk2?	N/A
	X Walk 1 Direction	To SW		X Walk 2 Direction	N/A
N/A	X Walk 1 Width (in)	N/A	N/A	X Walk 2 Width (in)	N/A
	X Walk 1 Slope (%)	4.8		X Walk 2 Slope (%)	N/A
	X Walk 1 X Slope (%)	2.0		X Walk 2 X Slope (%)	N/A

N/A	Ramp inside XWalk1?	N/A	N/A	Ramp inside XWalk2?	N/A
	Road Slope (%)	N/A	N/A	Clear Space?	N/A
	Road X Slope (%)	N/A	N/A	Clear Space to XWalk (in)	N/A
N/A	Any Obstructions?	N/A	N/A	Storm Grate/Utility Hazard?	N/A
	Obstruction Type			Storm Grate/Utility Type	
		N/A			N/A
			Yes	Surface Condition? (G/P)	Good

Possible Solutions:

Remove & Replace Entire Ramp.

Not Found, R304.2.2
