# Access Compliance Report

## Public Rights-of-Way (Curb Ramps)

Intersection ID: 29424	Main Street: BRADSTREET COMMONS WY	Cross Street: BRAWLEY LN	Location: SW
ADA ID: 75A86A2210E1	Ramp Type: Perp	Initial Pass/Fail: Fail	Overall Compliance: No
Severity Score: 12.5			
Codes/Mitigation Info/Possible Solution		Field Measurements/Component Compliance

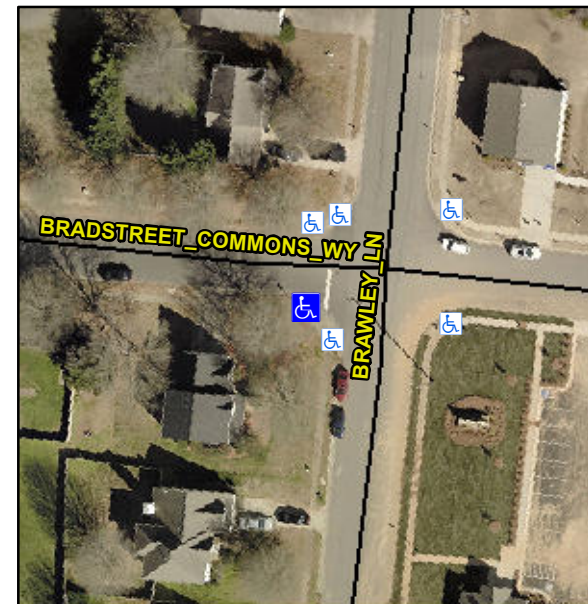
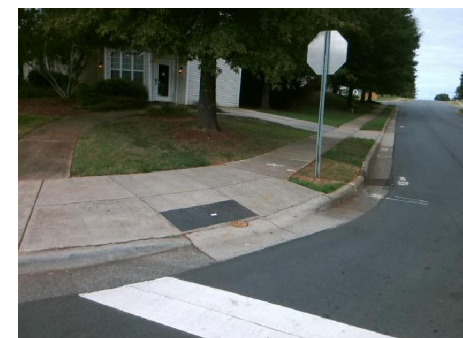
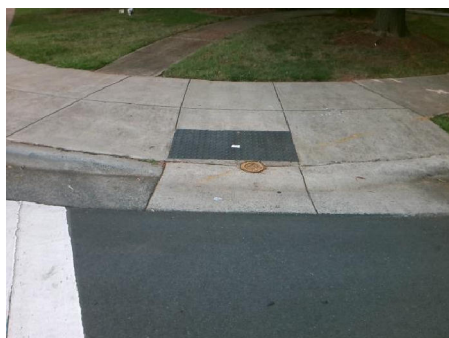
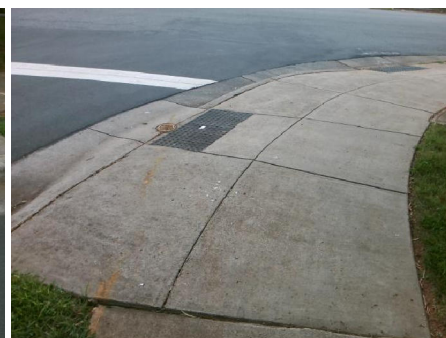
**Not Found, R304.2.2**

Compliance	Description	Data	Compliance	Description	Data
N/A	Ramp Length (in)	47.5	No	Ramp Slope (%)	10.9
Yes	Ramp Width (in)	48.0	Yes	Ramp XSlope (%)	1.7
N/A	Flare Type LT	N/A	N/A	Flare Type RT	N/A
N/A	Flare Slope LT (%)	N/A	N/A	Flare Slope RT (%)	N/A
N/A	Flare Traversable LT?	N/A	N/A	Flare Traversable RT?	N/A
N/A	Landing Length (in)	N/A	N/A	DWS Provided?	N/A
N/A	Landing Width (in)	N/A	N/A	DWS Contrast?	N/A
N/A	Landing Slope (%)	N/A	N/A	DWS Length (in)	N/A
N/A	Landing X Slope (%)	N/A	N/A	DWS Full Width?	N/A
N/A	Landing Curb? (Y/N)	N/A	N/A	DWS Offset (in)	N/A
N/A	Shared Landing?	N/A			
N/A	Gutter Ponding?	N/A	N/A	Gutter Slope (%)	N/A
N/A	Gutter Lip Ht (in)	N/A	N/A	Gutter X Slope (%)	N/A
N/A	Painted X Walk1?	No	N/A	Painted X Walk2?	N/A
	X Walk 1 Direction	To N		X Walk 2 Direction	N/A
N/A	X Walk 1 Width (in)	N/A	N/A	X Walk 2 Width (in)	N/A
	X Walk 1 Slope (%)	2.8		X Walk 2 Slope (%)	N/A
	X Walk 1 X Slope (%)	0.5		X Walk 2 X Slope (%)	N/A

N/A	Ramp inside XWalk1?	N/A	N/A	Ramp inside XWalk2?	N/A
	Road Slope (%)	N/A	N/A	Clear Space?	N/A
	Road X Slope (%)	N/A	N/A	Clear Space to XWalk (in)	N/A
N/A	Any Obstructions?	N/A	N/A	Storm Grate/Utility Hazard?	N/A
	Obstruction Type			Storm Grate/Utility Type	
		N/A			N/A
			Yes	Surface Condition? (G/P)	Good

**Remove & Replace Entire Ramp.**
