# Access Compliance Report

## Public Rights-of-Way

### (Curb Ramps)

Intersection ID: 43759	Main Street: DERVISH_LN	Cross Street: DUXFORD_LN	Location: NW
ADA ID: 75ABA84236B8	Ramp Type: BlendTrans1	Initial Pass/Fail: Fail	Overall Compliance: No
		Severity Score: 8.75

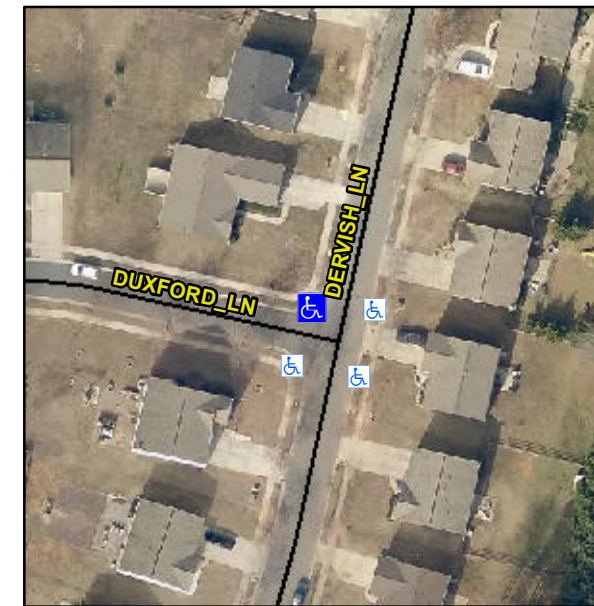
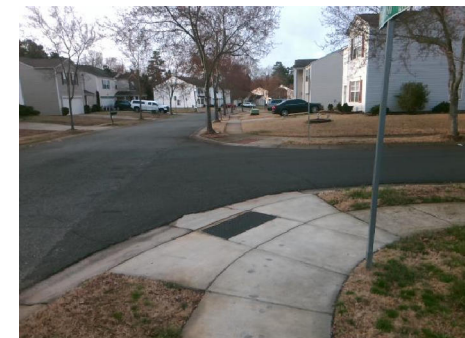
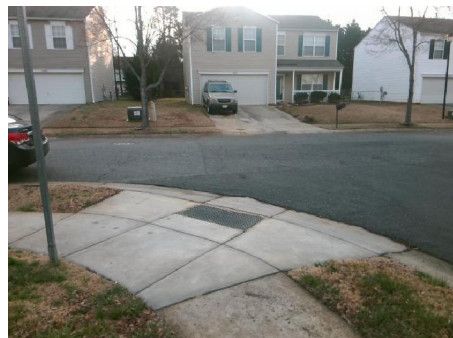
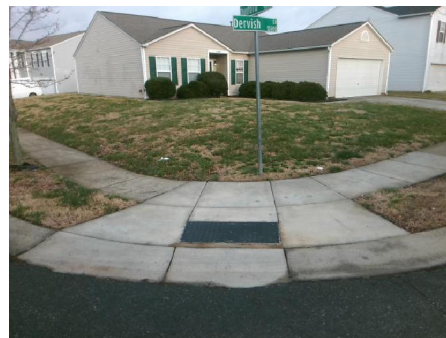
**Not Found, R304.5.1**

Compliance	Description	Data	Compliance	Description	Data
N/A	Ramp Length (in)	46.0	Yes	BlendTrans Slope (%)	2.7
No	Ramp Width (in)	46.5	Yes	BlendTrans XSlope (%)	0.5
N/A	Flare Type LT	N/A	N/A	Flare Type RT	N/A
N/A	Flare Slope LT (%)	N/A	N/A	Flare Slope RT (%)	N/A
N/A	Flare Traversable LT?	N/A	N/A	Flare Traversable RT?	N/A
N/A	Landing Length (in)	N/A	N/A	DWS Provided?	N/A
N/A	Landing Width (in)	N/A	N/A	DWS Contrast?	N/A
N/A	Landing Slope (%)	N/A	N/A	DWS Length (in)	N/A
N/A	Landing X Slope (%)	N/A	N/A	DWS Full Width?	N/A
N/A	Landing Curb? (Y/N)	N/A	N/A	DWS Offset (in)	N/A
N/A	Shared Landing?	N/A			
N/A	Gutter Ponding?	N/A	N/A	Gutter Slope (%)	N/A
N/A	Gutter Lip Ht (in)	N/A	N/A	Gutter X Slope (%)	N/A
N/A	Painted X Walk1?	No	N/A	Painted X Walk2?	No
	X Walk 1 Direction	To S		X Walk 2 Direction	To E
	X Walk 1 Width (in)	N/A		X Walk 2 Width (in)	N/A
	X Walk 1 Slope (%)	2.1		X Walk 2 Slope (%)	5.3
	X Walk 1 X Slope (%)	2.5		X Walk 2 X Slope (%)	0.1

N/A	Ramp inside XWalk1?	N/A	N/A	Ramp inside XWalk2?	N/A
	Road Slope (%)	0.7		Clear Space?	N/A
	Road X Slope (%)	4.5	N/A	Clear Space to XWalk (in)	N/A
N/A	Any Obstructions?	N/A	N/A	Storm Grate/Utility Hazard?	N/A
	Obstruction Type			Storm Grate/Utility Type	
		N/A			N/A
			Yes	Surface Condition? (G/P)	Good
			No	Curb Slope (%)	12.9

**Remove & Replace Curb Ramp With Two New Directional Ramps or Equivalent.**

Total Cost: \$ 3200.00
