Intersection ID: 8051	Main Street: AUSTIN_DR	Cross Street: MONTEITH_DR	Location:	NW
ADA ID: 75AF950EA091	Ramp Type: Para	Initial Pass/Fail: Fail	Overall Compliance: No	Severity Score: 13.75

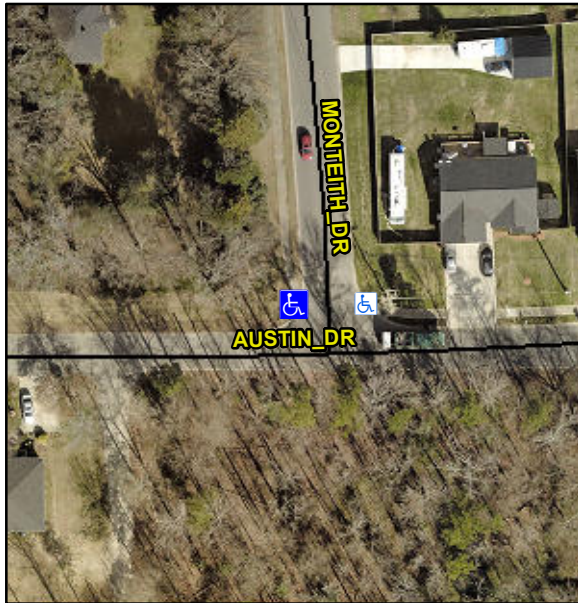
NO LT SW, LT RP < 5%

R304.3.2, R304.5.3

Compliance	Description	Data	Compliance	Description	Data
N/A	Ramp Length LT (in)	18.5	N/A	Ramp Length RT (in)	14.5
Yes	Ramp Width LT (in)	57.0	Yes	Ramp Width RT (in)	59.5
Yes	Ramp Slope LT (%)	2.8	No	Ramp Slope RT (%)	9.7
Yes	Ramp XSlope LT (%)	2.0	No	Ramp XSlope RT (%)	2.4
N/A	Landing Length (in)	N/A	N/A	DWS Provided?	N/A
N/A	Landing Width (in)	N/A	N/A	DWS Contrast?	N/A
N/A	Landing Slope (%)	N/A	N/A	DWS Length (in)	N/A
N/A	Landing X Slope (%)	N/A	N/A	DWS Full Width?	N/A
N/A	Landing Curb? (Y/N)	N/A	N/A	DWS Offset (in)	N/A
N/A	Shared Landing?	N/A			
N/A	Gutter Ponding?	N/A	N/A	Gutter Slope (%)	N/A
N/A	Gutter Lip Ht (in)	0.5	N/A	Gutter X Slope (%)	N/A
N/A	Painted X Walk1?	No	N/A	Painted X Walk2?	N/A
	X Walk 1 Direction	To E		X Walk 2 Direction	N/A
N/A	X Walk 1 Width (in)	N/A	N/A	X Walk 2 Width (in)	N/A
	X Walk 1 Slope (%)	0.2		X Walk 2 Slope (%)	N/A
	X Walk 1 X Slope (%)	1.6		X Walk 2 X Slope (%)	N/A
N/A	Ramp inside XWalk1?	N/A	N/A	Ramp inside XWalk2?	N/A

Road Slope (%)	N/A	N/A	Clear Space?	N/A
	Road X Slope (%)	N/A	N/A	Clear Space to XWalk (in)	N/A
N/A	Any Obstructions?	N/A	N/A	Storm Grate/Utility Hazard?	N/A
	Obstruction Type			Storm Grate/Utility Type	
		N/A			N/A
			Yes	Surface Condition? (G/P)	Good
			N/A	Curb Slope (%)	18.0

Remove & Replace Entire Ramp.
