# Access Compliance Report

## Public Rights-of-Way

### (Curb Ramps)

Intersection ID: 27951	Main Street: EDINDALE_DR	Cross Street: SCOURIE_LN	Location: SE
ADA ID: 75C4D7110AE8	Ramp Type: PerpDiag	Initial Pass/Fail: Fail	Overall Compliance: No
Severity Score: 12.5			
Codes/Mitigation Info/Possible Solution		Field Measurements/Component Compliance

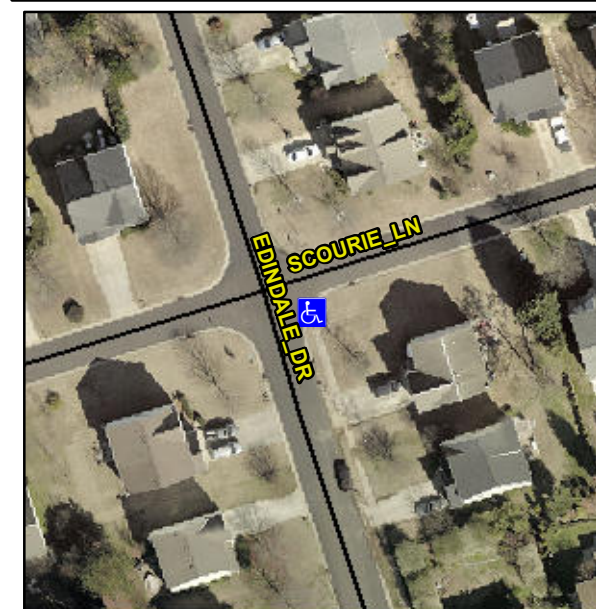
Compliance	Description	Data	Compliance	Description	Data
N/A	Ramp Length (in)	42.0	Yes	Ramp Slope (%)	6.8
Yes	Ramp Width (in)	48.0	No	Ramp XSlope (%)	5.6
N/A	Flare Type LT	N/A	N/A	Flare Type RT	N/A
N/A	Flare Slope LT (%)	N/A	N/A	Flare Slope RT (%)	N/A
N/A	Flare Traversable LT?	N/A	N/A	Flare Traversable RT?	N/A
N/A	Landing Length (in)	N/A	N/A	DWS Provided?	N/A
N/A	Landing Width (in)	N/A	N/A	DWS Contrast?	N/A
N/A	Landing Slope (%)	N/A	N/A	DWS Length (in)	N/A
N/A	Landing X Slope (%)	N/A	N/A	DWS Full Width?	N/A
N/A	Landing Curb? (Y/N)	N/A	N/A	DWS Offset (in)	N/A
N/A	Shared Landing?	N/A			
N/A	Gutter Ponding?	N/A	N/A	Gutter Slope (%)	N/A
N/A	Gutter Lip Ht (in)	N/A	N/A	Gutter X Slope (%)	N/A
N/A	Painted X Walk1?	No	N/A	Painted X Walk2?	No
	X Walk 1 Direction	To N		X Walk 2 Direction	To W
N/A	X Walk 1 Width (in)	N/A	N/A	X Walk 2 Width (in)	N/A
	X Walk 1 Slope (%)	0.3		X Walk 2 Slope (%)	17.0
	X Walk 1 X Slope (%)	1.1		X Walk 2 X Slope (%)	0.8

N/A	Ramp inside XWalk1?	N/A	N/A	Ramp inside XWalk2?	N/A
	Road Slope (%)	1.5	N/A	Clear Space?	N/A
	Road X Slope (%)	2.2	N/A	Clear Space to XWalk (in)	N/A
N/A	Any Obstructions?	N/A	N/A	Storm Grate/Utility Hazard?	N/A
	Obstruction Type			Storm Grate/Utility Type	
		N/A			N/A
		Yes		Surface Condition? (G/P)	Good

**Remove & Replace Curb Ramp With Two New Directional Ramps or Equivalent.**
