Access Compliance Report

Public Rights-of-Way

(Curb Ramps)

| Intersection ID: 45130 | Main Street: DULIN_CREEK_BV | Cross Street: PLAZA_RD_EXT | Location: SE |

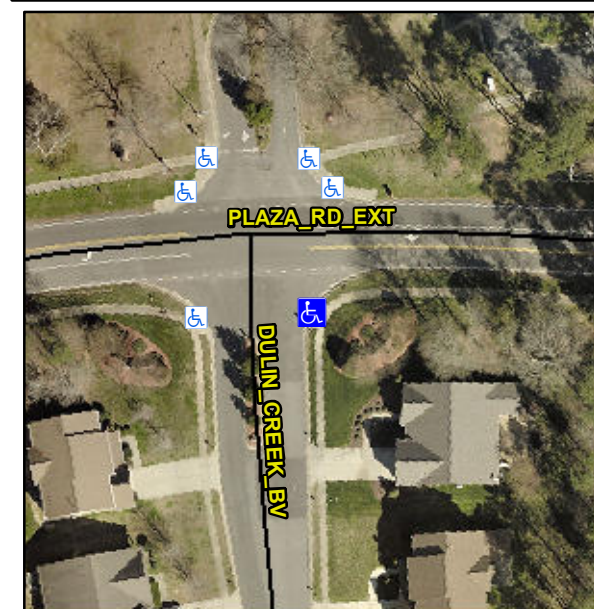
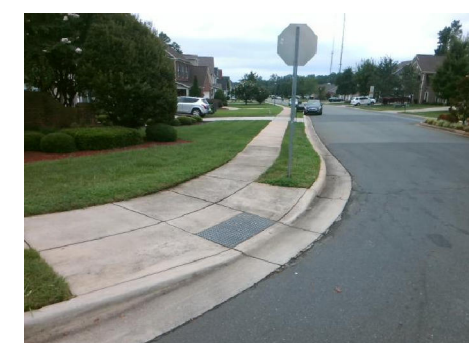
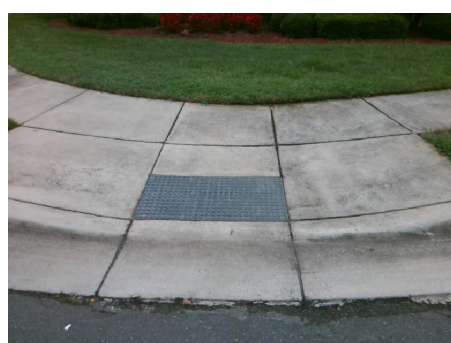
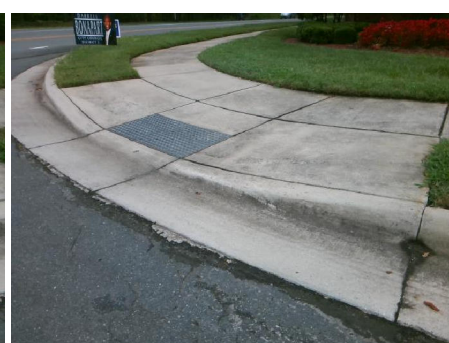
Not Found, R304.5.1

| Compliance | Description | Data | Compliance | Description | Data |
|---|---|---|---|---|---|
| No | Ramp Width (in) | 46.5 | Yes | Ramp XSlope (%) | 1.3 |

Remove & Replace Curb Ramp With Two New Directional Ramps or Equivalent.
