# Access Compliance Report

## Public Rights-of-Way

### (Curb Ramps)

| Intersection ID: 10020989 | Main Street: BERE_ISLAND_DR | Cross Street: N/A | Location: SW |

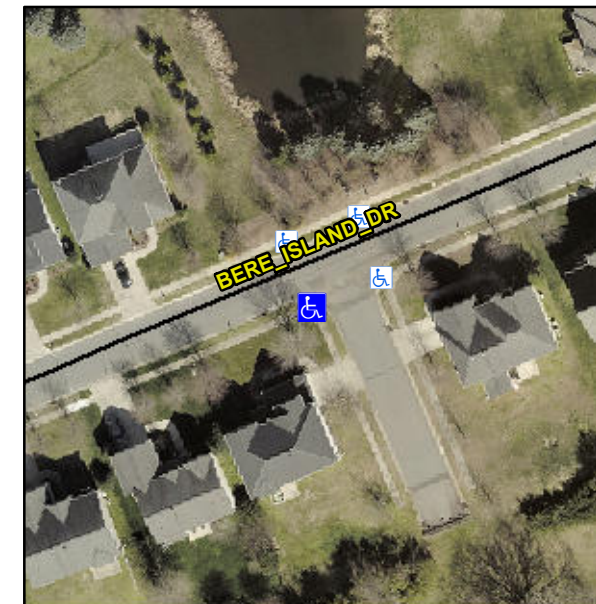
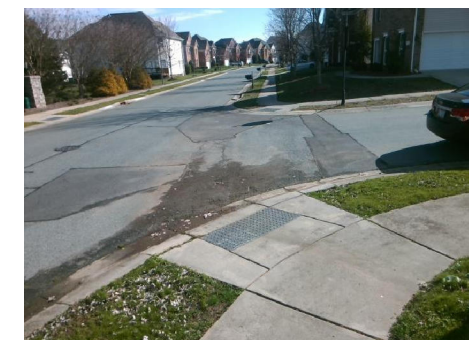
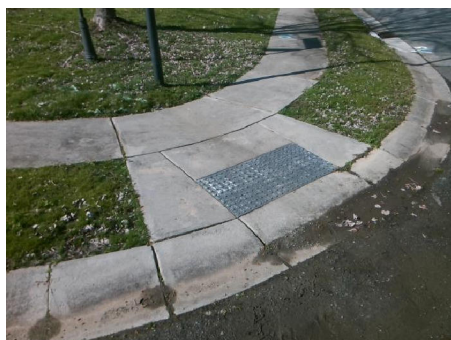
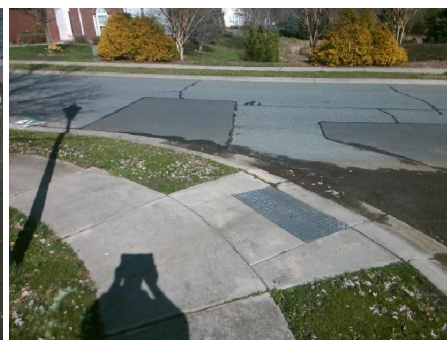
| ADA ID: 75CF3C2D1EC3 | Ramp Type: PerpDiag | Initial Pass/Fail: Pass | Overall Compliance: No |
| Severity Score: 0.25 | | | |

**Not Found, R304.5.3, R304.2.1, R305.2**

| Compliance | Description | Data | Compliance | Description | Data |
|---|---|---|---|---|---|
| Yes | Ramp Width (in) | 48.0 | No | Ramp XSlope (%) | 2.1 |
| No | Landing Length (in) | 47.0 | Yes | DWS Provided? | Yes |

**Remove & Replace Curb Ramp With Two New Directional Ramps or Equivalent.**

Total Cost: \$ 3200.00
