# Access Compliance Report

## Public Rights-of-Way

### (Curb Ramps)

Intersection ID: 6987	Main Street: W_ROCKY_RIVER_RD	Cross Street: ROCKLAND_DR	Location: NW
ADA ID: 75D591421F34	Ramp Type: Perp	Initial Pass/Fail: Fail	Overall Compliance: No
		Severity Score: 1.25

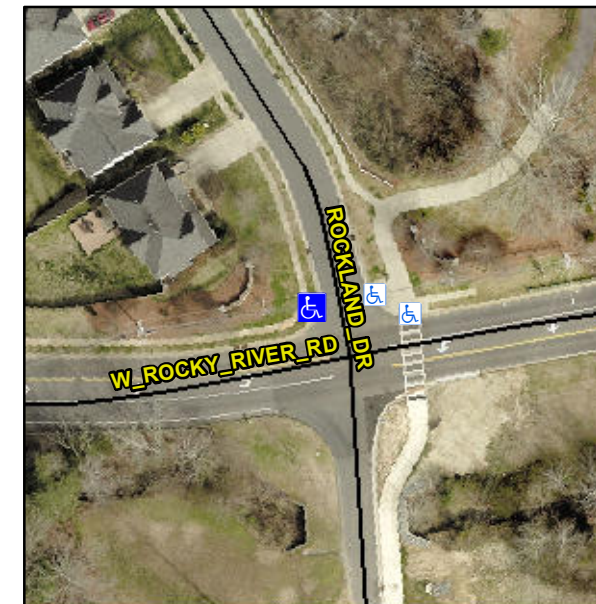
**Not Found, R304.5.3**

Compliance	Description	Data	Compliance	Description	Data
N/A	Ramp Length (in)	48.0	Yes	Ramp Slope (%)	8.3
Yes	Ramp Width (in)	48.0	No	Ramp XSlope (%)	4.2
N/A	Flare Type LT	N/A	N/A	Flare Type RT	N/A
N/A	Flare Slope LT (%)	N/A	N/A	Flare Slope RT (%)	N/A
N/A	Flare Traversable LT?	N/A	N/A	Flare Traversable RT?	N/A
N/A	Landing Length (in)	N/A	N/A	DWS Provided?	N/A
N/A	Landing Width (in)	N/A	N/A	DWS Contrast?	N/A
N/A	Landing Slope (%)	N/A	N/A	DWS Length (in)	N/A
N/A	Landing X Slope (%)	N/A	N/A	DWS Full Width?	N/A
N/A	Landing Curb? (Y/N)	N/A	N/A	DWS Offset (in)	N/A
N/A	Shared Landing?	N/A			
N/A	Gutter Ponding?	N/A	N/A	Gutter Slope (%)	N/A
N/A	Gutter Lip Ht (in)	0.75	N/A	Gutter X Slope (%)	N/A
N/A	Painted X Walk1?	No	N/A	Painted X Walk2?	N/A
	X Walk 1 Direction	To E		X Walk 2 Direction	N/A
N/A	X Walk 1 Width (in)	N/A	N/A	X Walk 2 Width (in)	N/A
	X Walk 1 Slope (%)	0.4		X Walk 2 Slope (%)	N/A
	X Walk 1 X Slope (%)	6.0		X Walk 2 X Slope (%)	N/A

N/A	Ramp inside XWalk1?	N/A	N/A	Ramp inside XWalk2?	N/A
	Road Slope (%)	N/A	N/A	Clear Space?	N/A
	Road X Slope (%)	N/A	N/A	Clear Space to XWalk (in)	N/A
N/A	Any Obstructions?	N/A	N/A	Storm Grate/Utility Hazard?	N/A
	Obstruction Type			Storm Grate/Utility Type	
		N/A			N/A
			Yes	Surface Condition? (G/P)	Good

**Remove & Replace Entire Ramp.**
